LOCH RESTORATION

- SEPA's perspective

Louise Bond, SEPA

8th April 2010

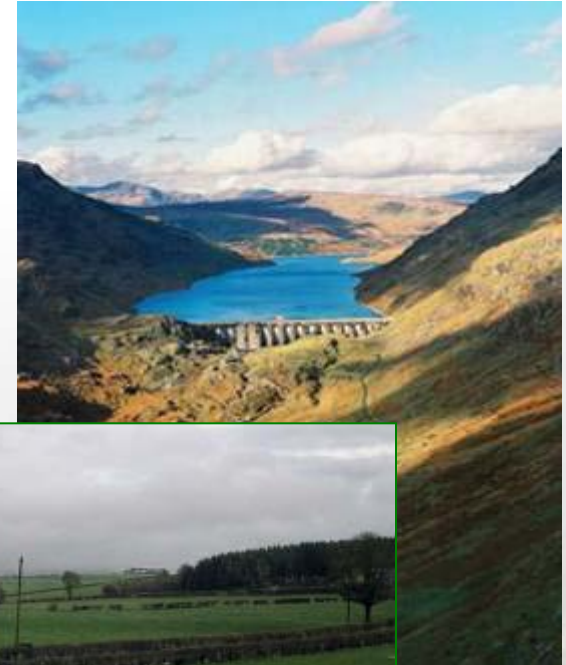
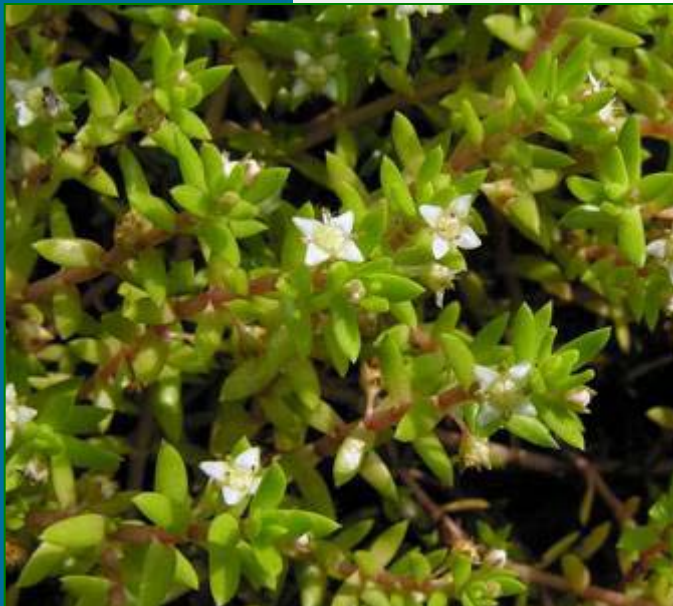
NZ Pygmyweed (*Crassula helmsii*)

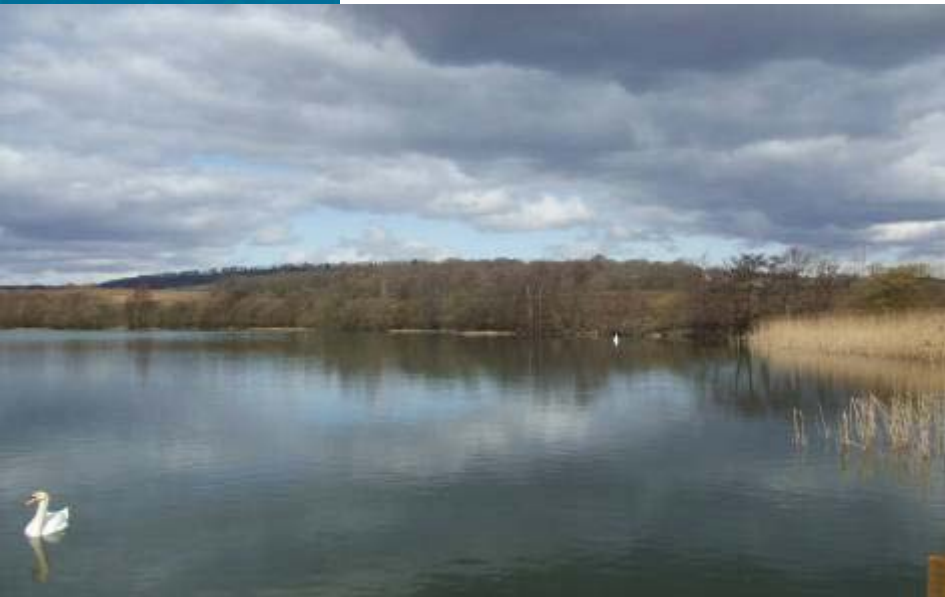
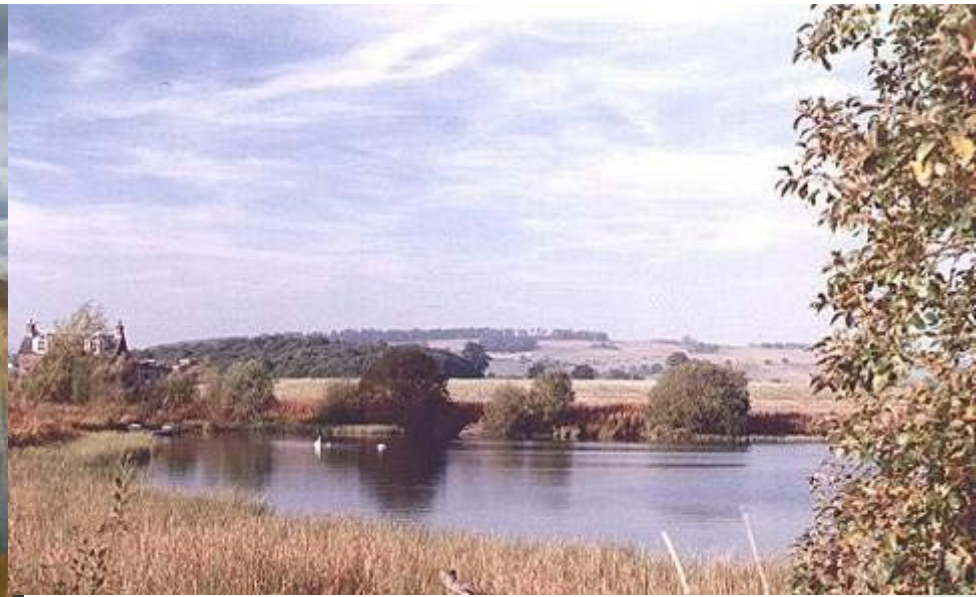
Fingask & White Lochs, Tayside

- Small lochs <12 ha, flora indicative of mesotrophic status
- Records biodiversity priority species: slender naiad (*Najas flexilis*) 2008/09, Shetland pondweed (*Potamogeton rutilis*) Fingask 2005. Rough stonewort (*Chara aspera*) and bristly stonewort (*C. hispida*) 1999
- V small populations, nutrient enrichment, cyanobacterial blooms in recent years
- WFD TP classification = moderate status

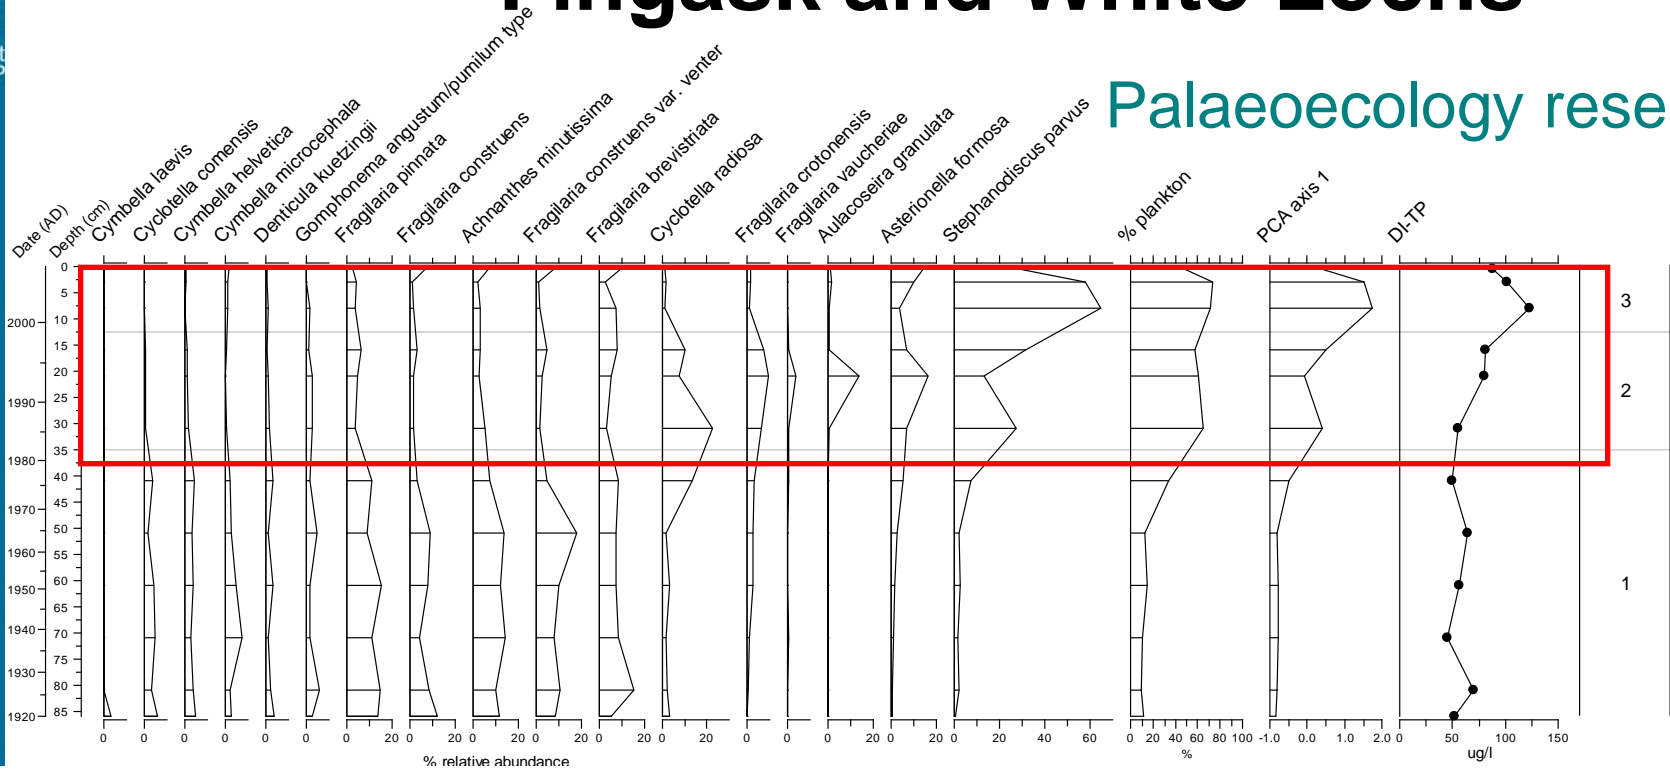
Palaeoecology research

White Loch formerly supported diatom and Cladocera communities typical of a mesotrophic loch

These have both undergone changes associated with enrichment most notably since ~1970.

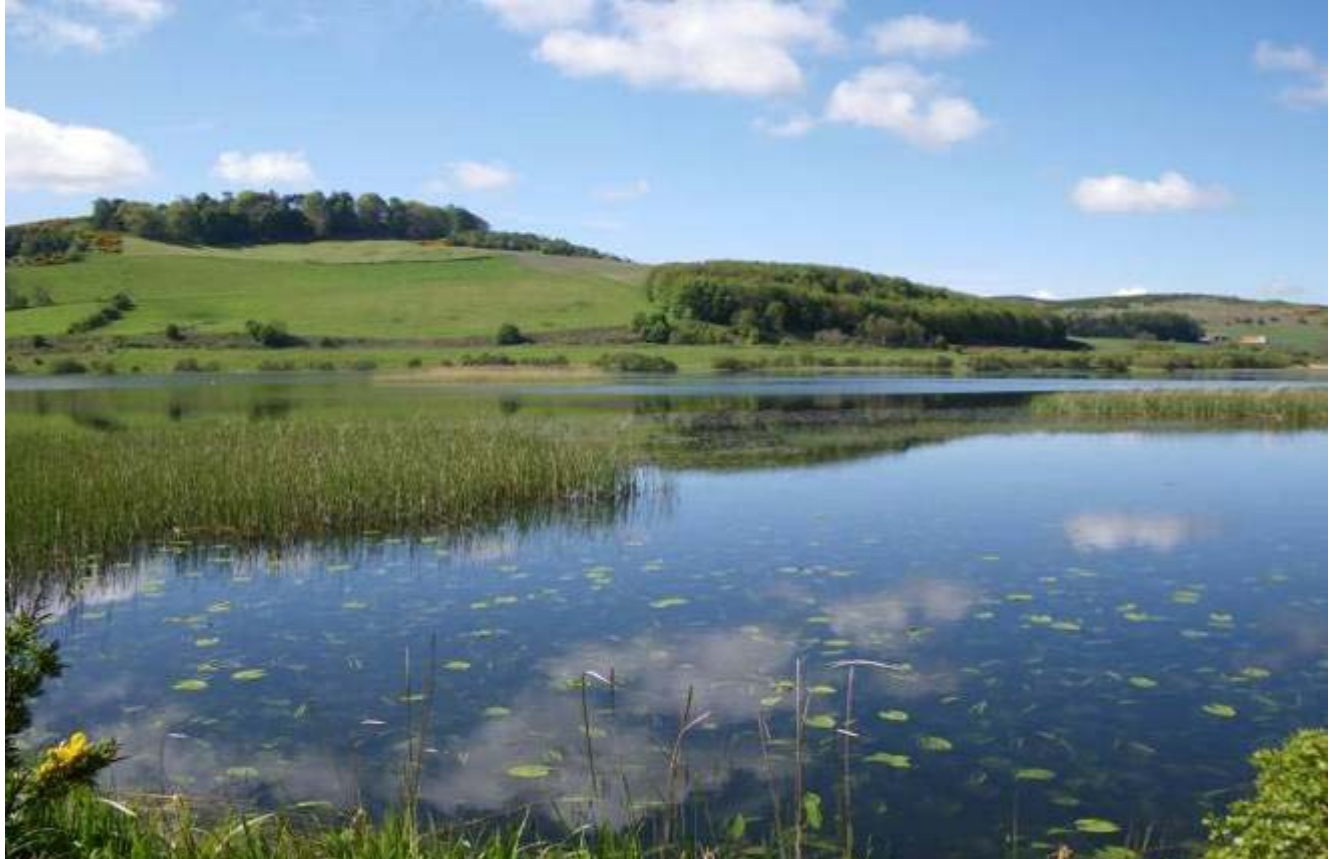
Lindores Loch EIAP

40.5 ha, shallow lowland mesotrophic loch, near Newburgh

Extensive charophyte beds, largest number of *Potamogeton* species of any open water site in Fife (historical macrophyte records - Fife loch survey)

Formerly support BAP priority spp *Najas flexilis* (slender naiad) - 2000

Extensive freshwater mire, adjoining rich-fen and alder willow carr

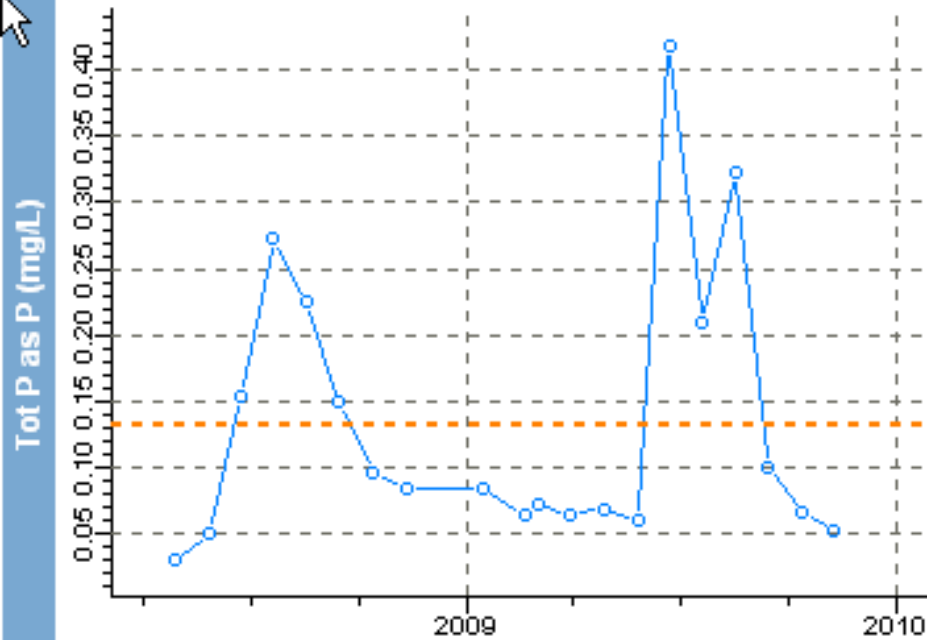
Lindores Loch

Start Date	End Date	Samples	Mean	Stdev	Min	Max
28/04/2008	09/11/2009	20	0.132	0.105	0.03	0.419

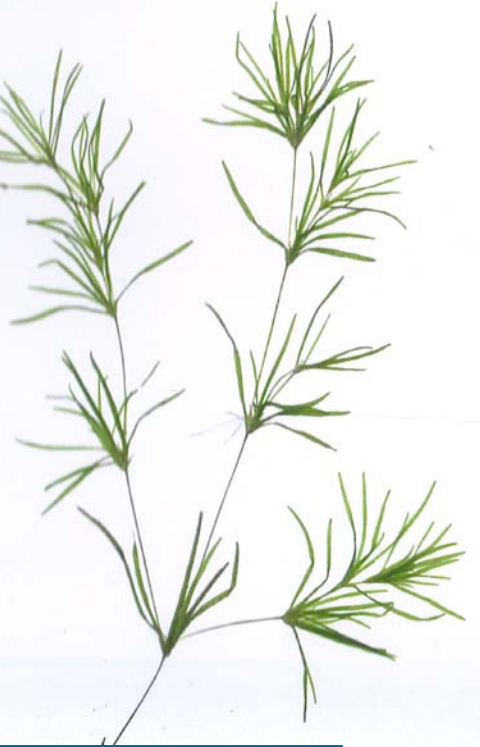
Slender naiad (*Najas flexilis*)

- Loch a'chclair (3.1ha, Olig, Tiree) - July 2009
Potamogeton rutilus abundant, Nationally scarce *Chara aspera* was also recorded.
- Loch Gorm (271ha, meso, Islay) - September 2009
Slender naiad (*Najas flexilis*) was present in great abundance in the shore line. *Nitella confervacea* was found during the 2008 survey, this species is Nationally Scarce and very sparsely recorded in northern and western Scotland. Nearest records are from Coll (new record).
- Loch nan Gad (9.7ha, meso, Kennacraig) Macrophyte data 2008- *Elodea canadensis* found and *Najas flexilis* confined to the west shore of the loch, where it was deeper and less silty. *Elatine hexandra* and the Nationally Scarce *Chara aspera* were also recorded.
2009 slender naiad recorded

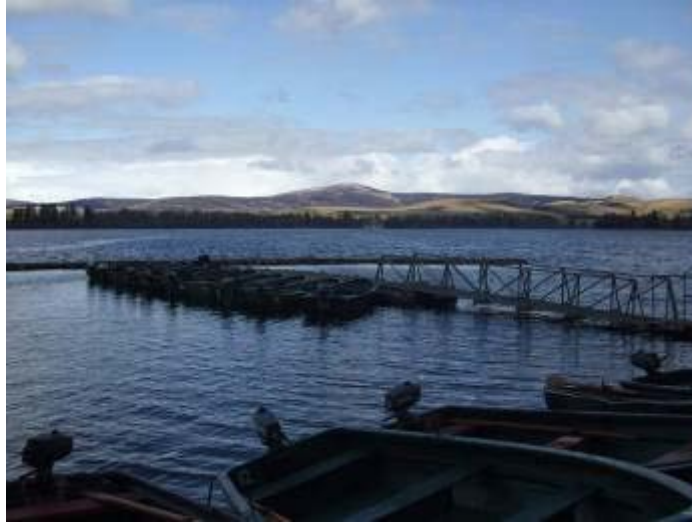
Loch of Lintrathen

- 169 Ha - SSSI, SPA, Ramsar site, SWT Reserve, drinking water supply
- Partnership group - Scottish Water, Bell Ingram, SEPA, SWT, local angling club, SNH, SEPA, Littlewood Landcare, Tayside LBAP
- DP catchment walks (July 2010), farm audits autumn
