Saltmarsh Accretion Monitoring Network Installation Report

Interim report

Client Ref: 08318-02

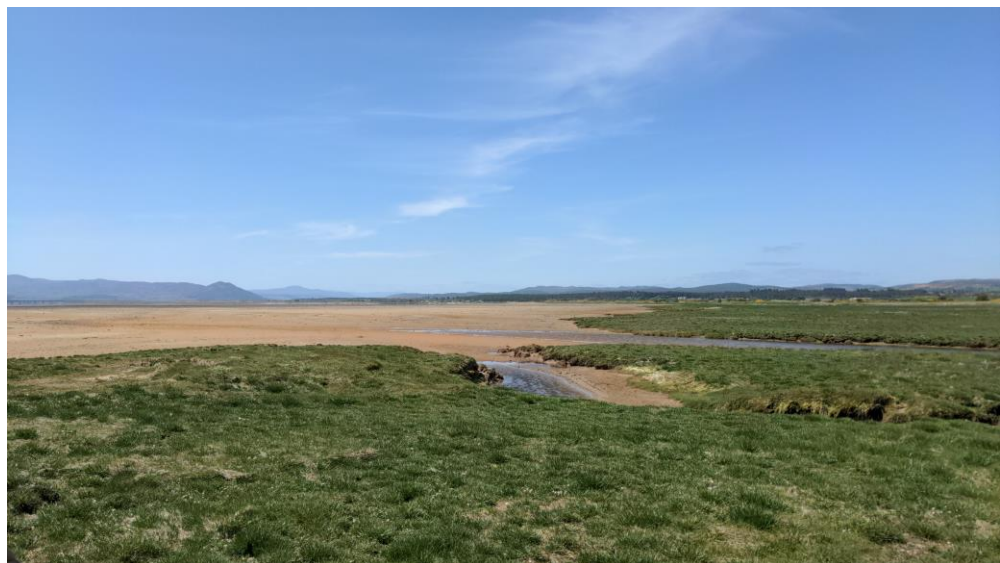
Image 2: View of the marsh edge facing North West from SET DFDP1. The channels are shallow, with little evidence of erosion, the marsh edge descends directly onto to the beach

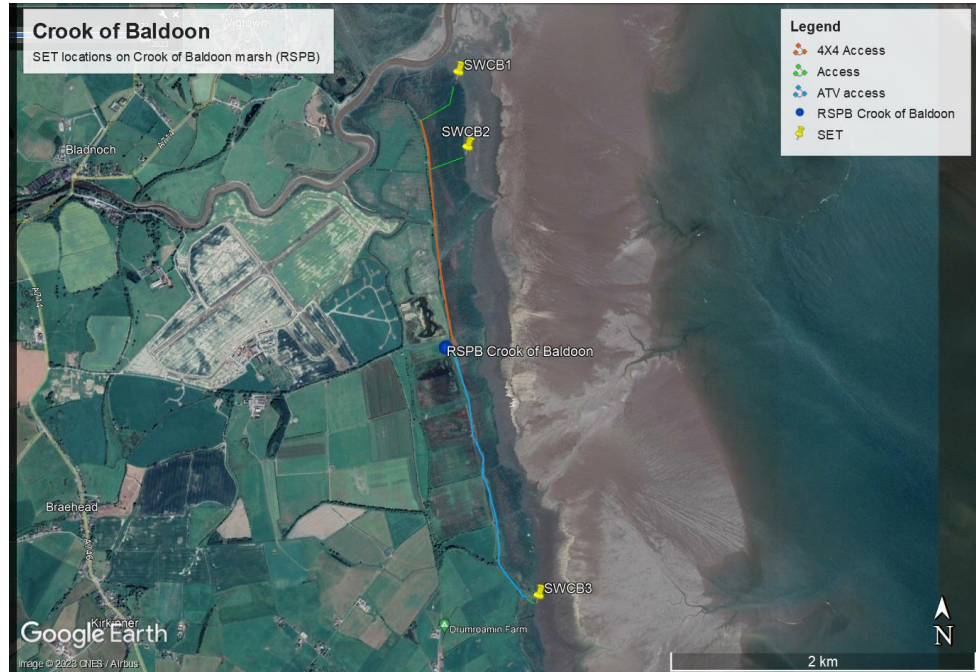
Image 3: Aerial photo of Crook of Baldoon marsh with SET locations indicated by pins and access outlined in red via 4x4, in blue via ATV and in green by foot across the marsh.

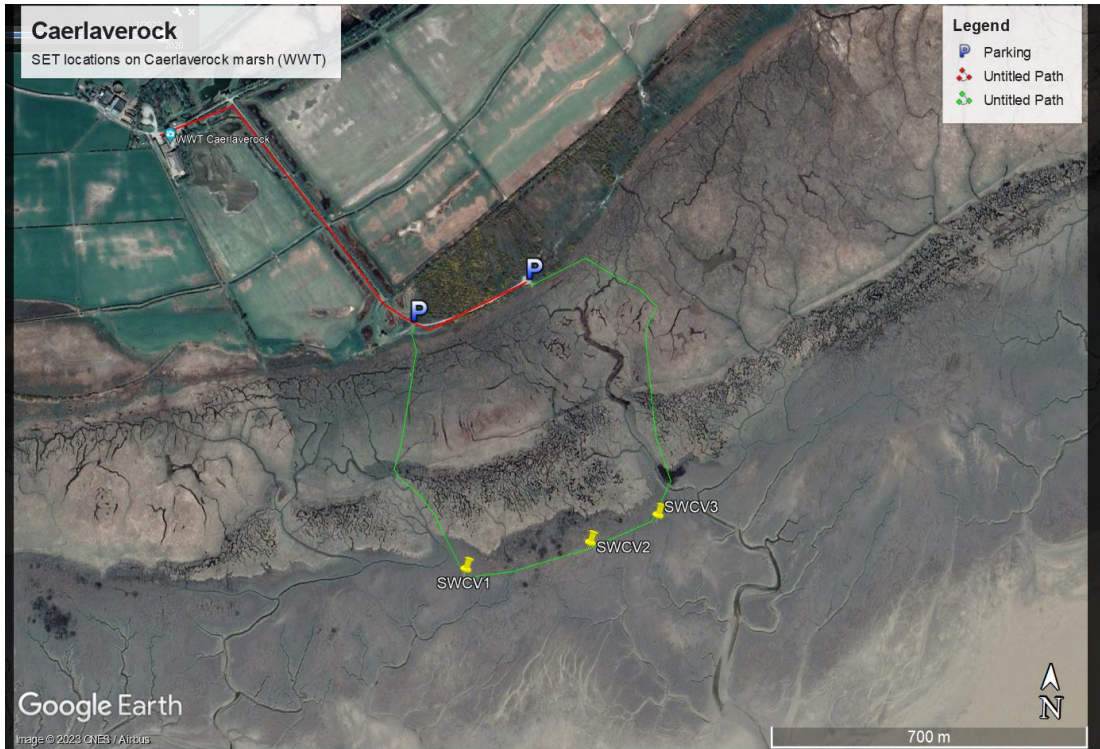
Image 5 Aerial photo of Caerlaverock marsh with SET locations indicated by pins and access outlined in red via a track and in green across the marsh.

Caerlaverock marsh is owned and managed by the Wildfowl and Wetlands Trust, where a birdwatching centre is located and frequented by members of the public. A building is situated on the seawall, providing a viewing point for visitors who do not have access to the marsh. The marsh is periodically grazed by a small number of sheep.

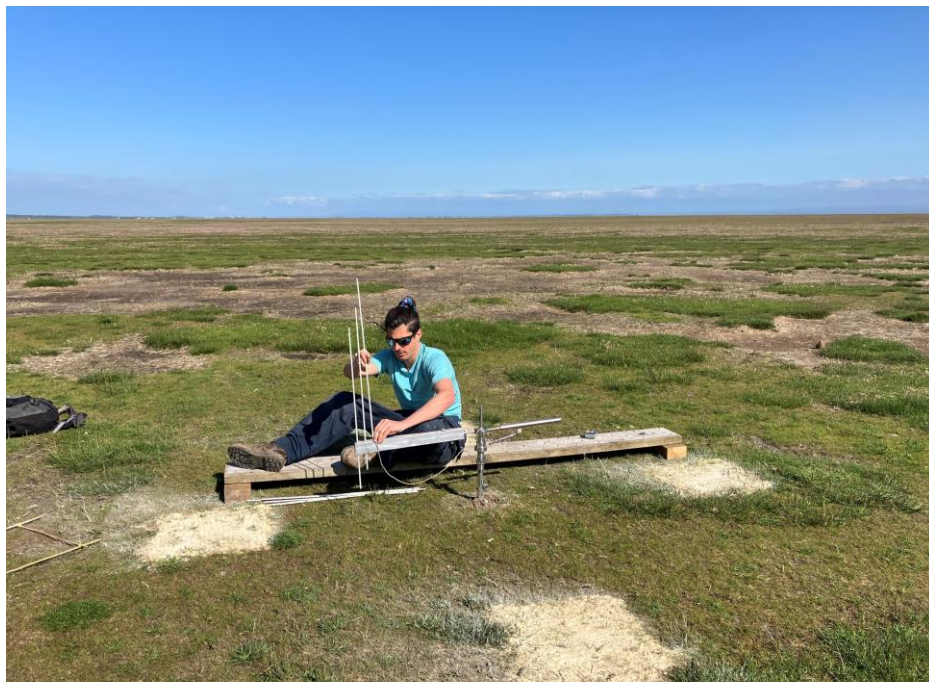
Image 6: Taking measurements at SET SWCV2 facing East.

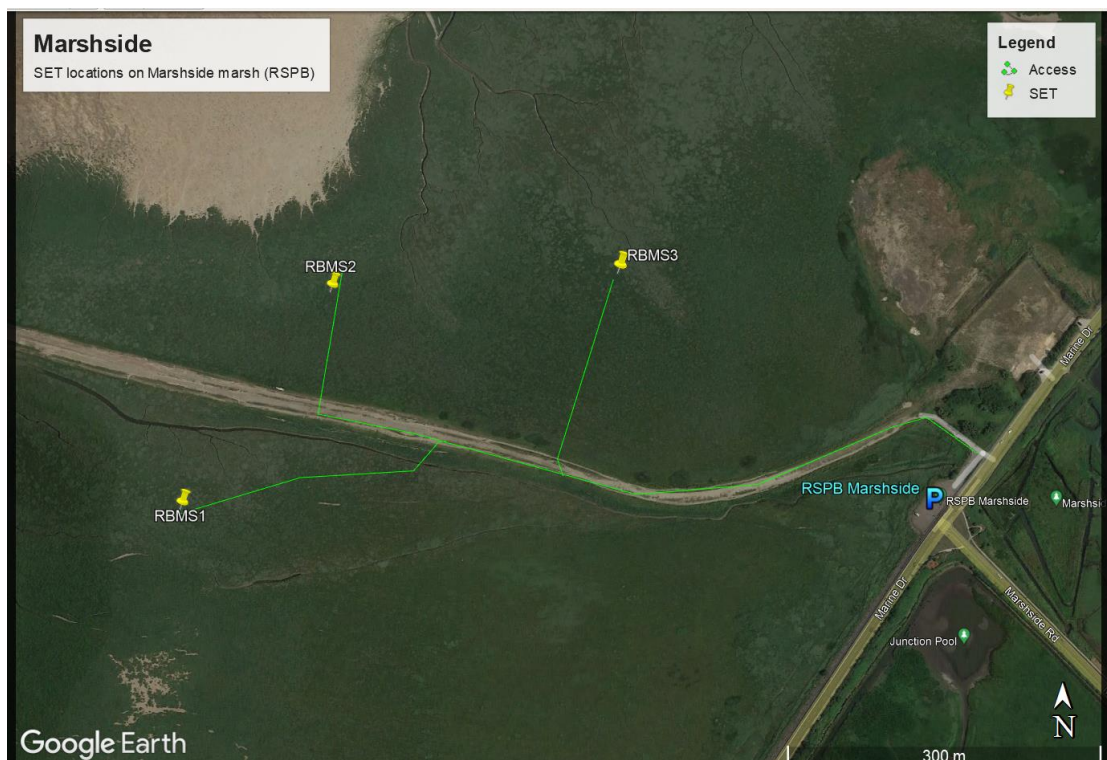
Image 9: Aerial photo of Marshside with SET locations indicated by pins and access via a track and across the marsh outlined in green.

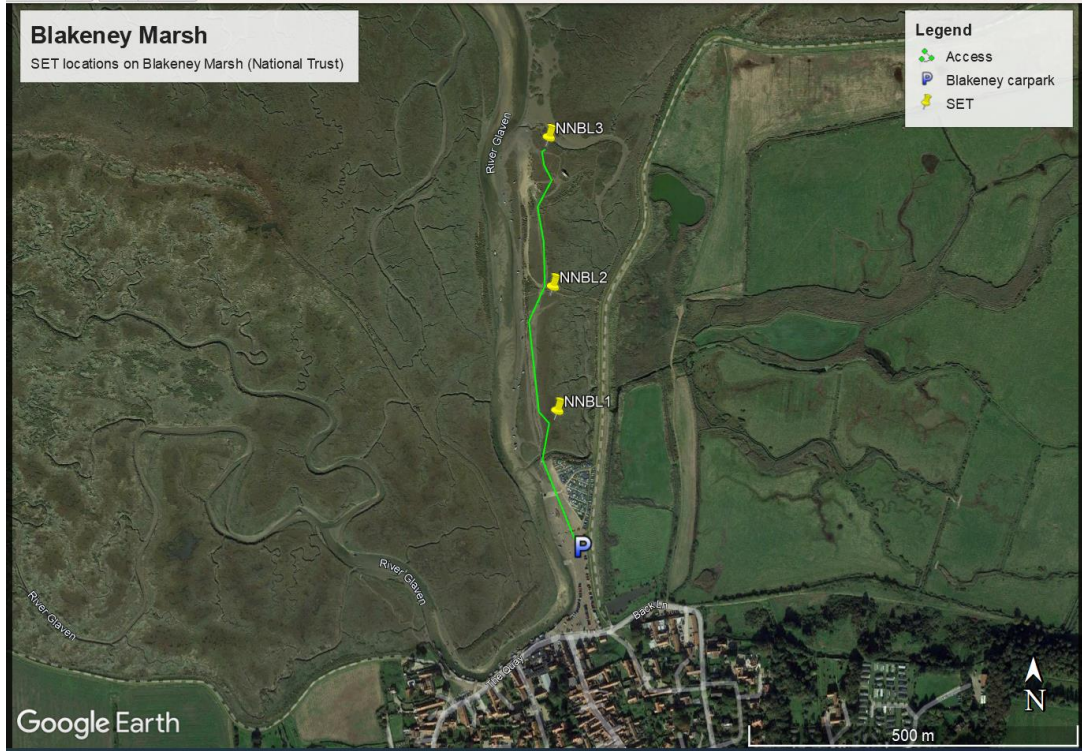
Image 15: Aerial photo of Blakeney Marsh with SET locations indicated by pins and access via a path outlined in green.

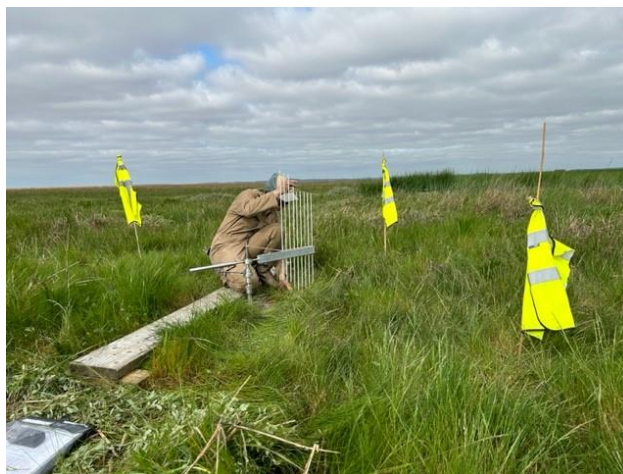
Image 18: Photo of example plot on Bulldog sand marsh (Eastern side). Measurements are being taken from WSBE3. Fluorescent flags are used to stake out the locations before transporting equipment, but here at the last site of the day, they are used to indicate marker horizon locations.

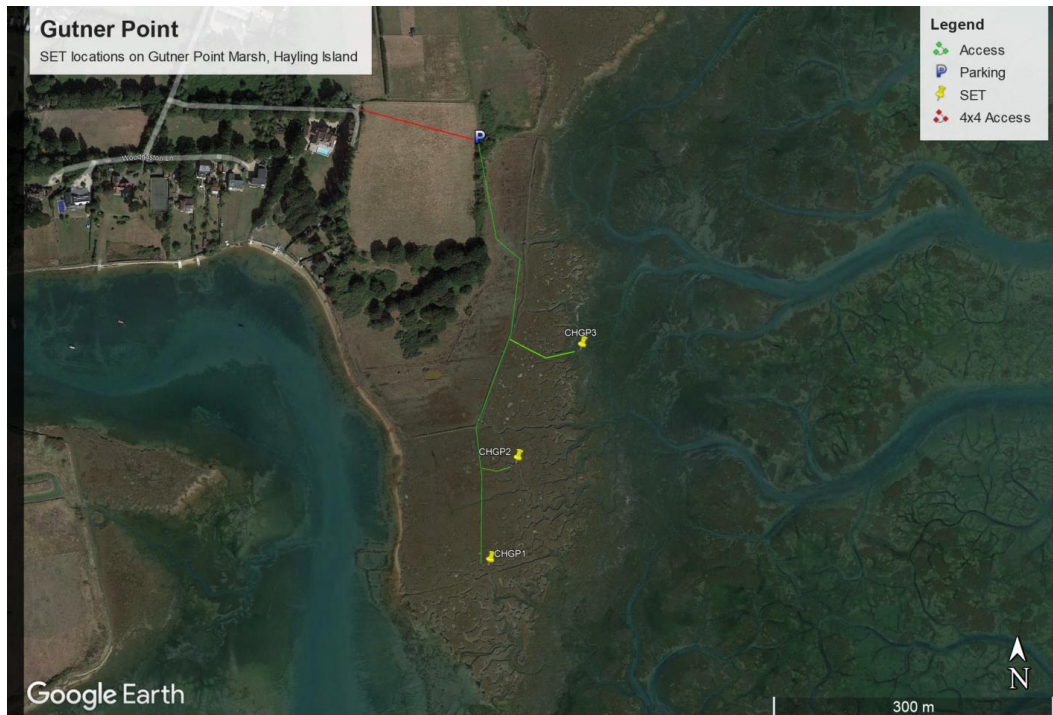
Image 23: Aerial photo of Gutner Point Marsh with SET locations indicated by pins, permitted 4x4 access across a field indicated in red, and access across the marsh outlined in green.

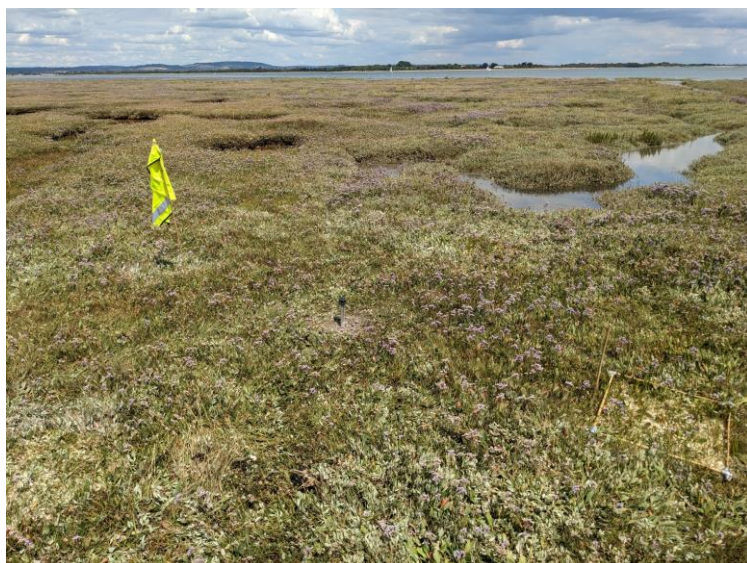
Image 24: Example plot CHGP1 on Gutner Point marsh. Marker horizons are just visible.

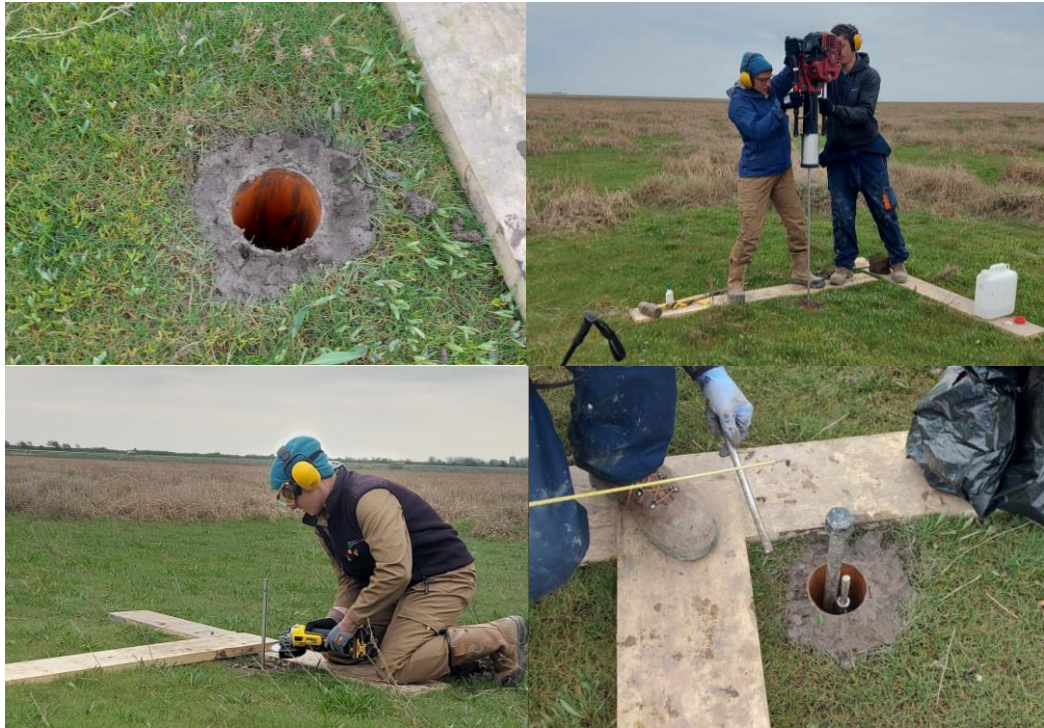
Soil pipe inserted into the ground at Marshside from a scaffolding plank to reduce damage to plants from footfall (Top Left). Two people operating the post-driver to insert mounting posts on Marshside marsh (Top Right). Setting up to angle-grinding the protruding post (Bottom Left). Receiver post fastened in place (Bottom Right)

- After identifying a suitable location, a 15cm diameter x 30cm deep hole was dug into which a 15cm x 50cm soil pipe was inserted.
- A modular 14mm stainless steel mounting post was driven into the sediment using a post-driver, threading in 1m lengths one at a time until bedrock was hit or the substrate was extremely difficult to get through.
- Any protruding length of post was cut off to ground level using an angle grinder. The receiver post was then attached to the post below ground level, with approximately 10cm protruding. The post was then set in place using postcrete.
- Location, post depth and plant community were recorded.

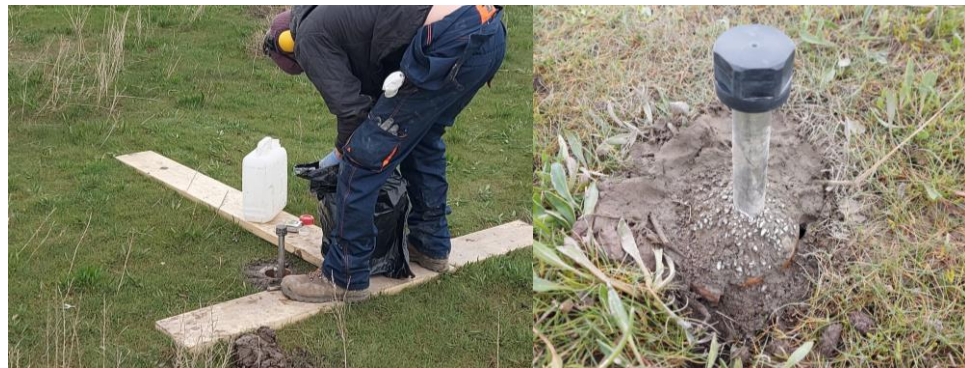
Setting the SET in with postcrete (Left). Installed SET base (Right).

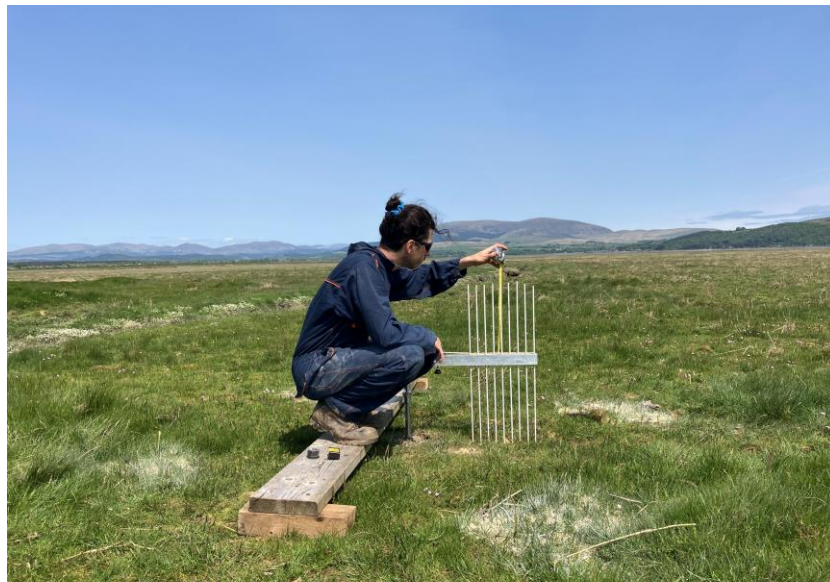
Taking measurements on the Crook of Baldoon marsh. Feldspar clay patches are visible in the foreground.

- Measurements were taken at 8 orientations **instead of 4** to inform on the error of measurements and provide a suitable baseline. This will aid a more accurate measurement of elevation prior to adjustments being made to the instrument.
- Elevation was measured on 9 pins slotted into the device arm, which was levelled using a digital level. The arm was then lifted and rotated to the next position, levelled and pins measured.
