Hydraulic and geomorphic effects of placed large wood structures. A two-year case study.

Introduction

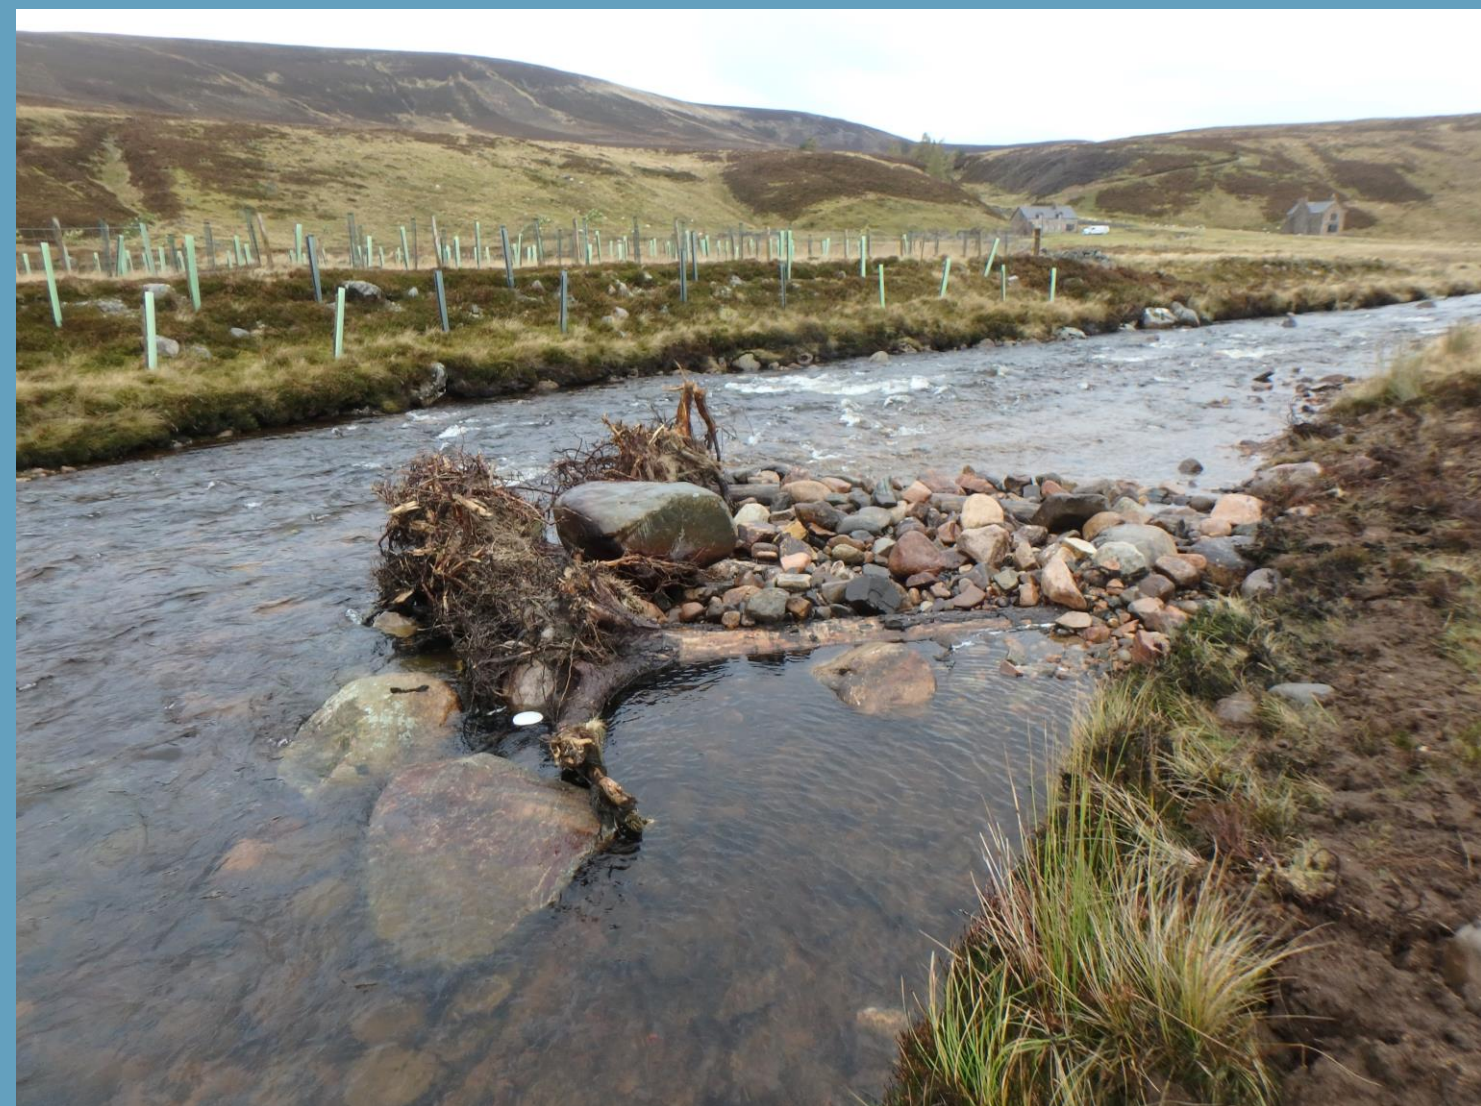
Figure 1 A lateral, bank attached LWS (LWS2) shortly after installation.

Purposely placed large wood structures (LWS) of a variety of complexity and degree of engineering, have been installed to enhance the habitat of Atlantic salmon (Figure 1). The evidence surrounding the effects of LWS is currently lacking, however.

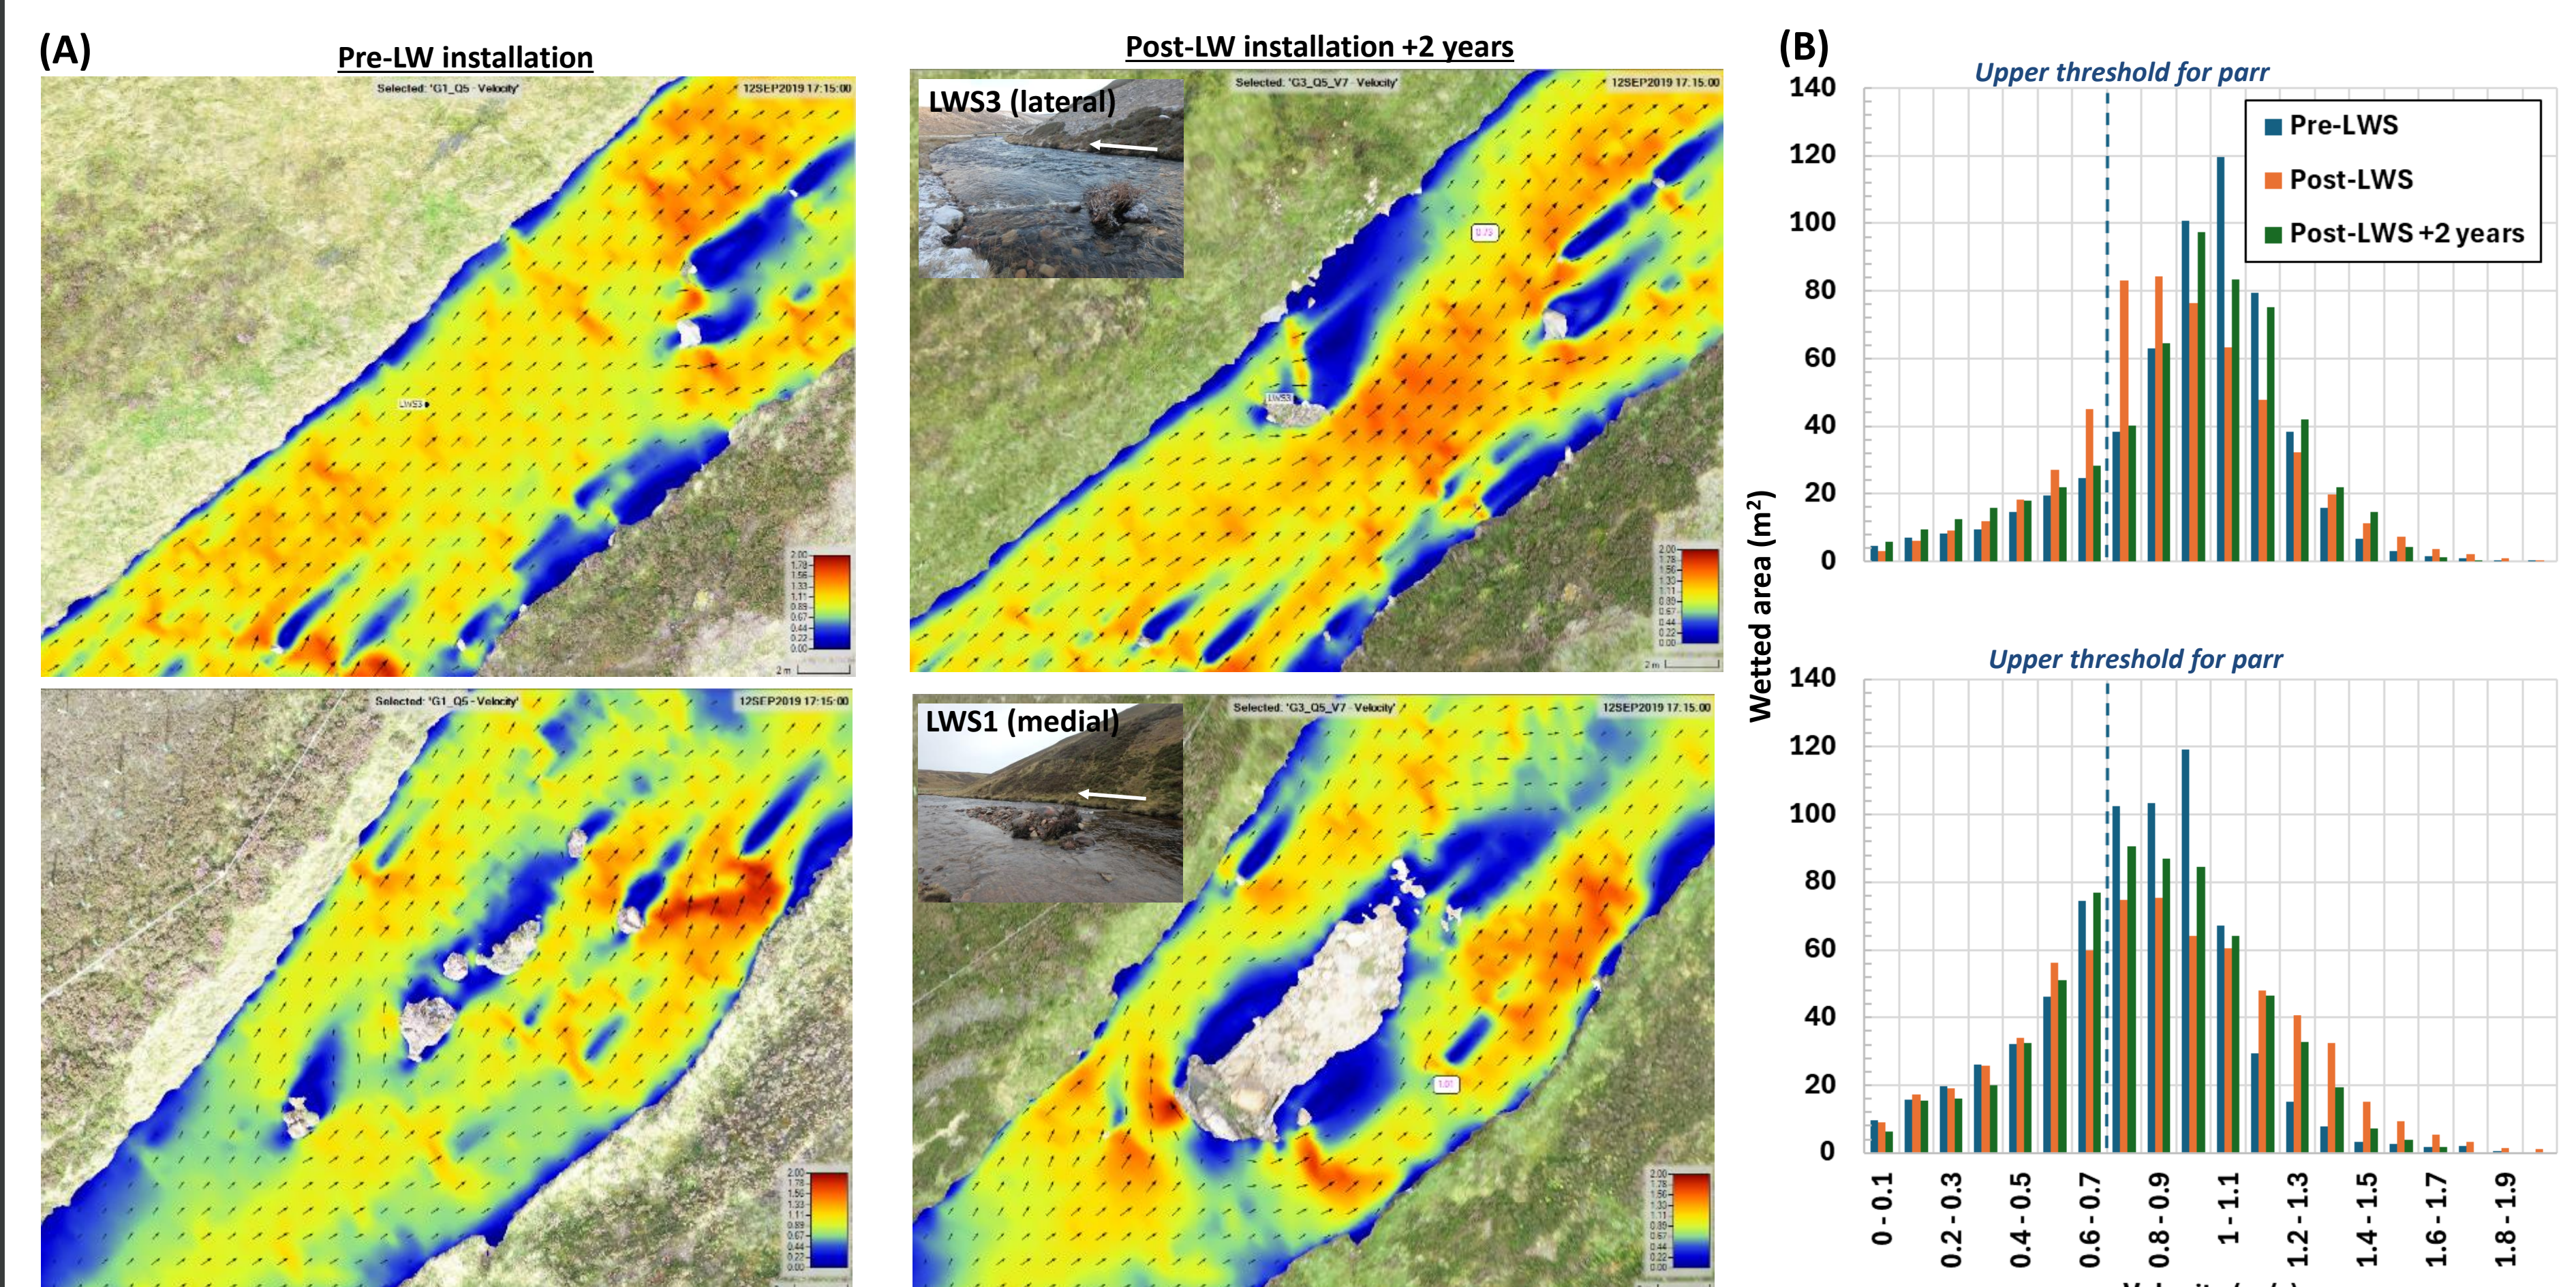
Figure 4(A) Modelled depth averaged water velocities and vectors before and after LW installation for a Q₅ flow (3.1 m³/s). (B) Corresponding velocity distributions for each condition relative to theoretical high velocity tolerance threshold for Atlantic salmon parr of 0.7 m/s (based on velocity tolerance range of Heggnes et al. 1999).

- For a Q₅ flow, the structures locally diverted velocities and created slack water areas (Figure 4). Change in usable habitat area for juvenile fish was variable, greater for lateral structures and on average increased by 5.6% after two years (Figure 5).
- Net morphological change was uniformly erosional but often subtle, change was higher for medial structures compared to lateral structures and increased with greater blockage ratios (Figure 6 & 7).
- Further work will explore hydraulic patterns in relation to morphological change and consider different flows.

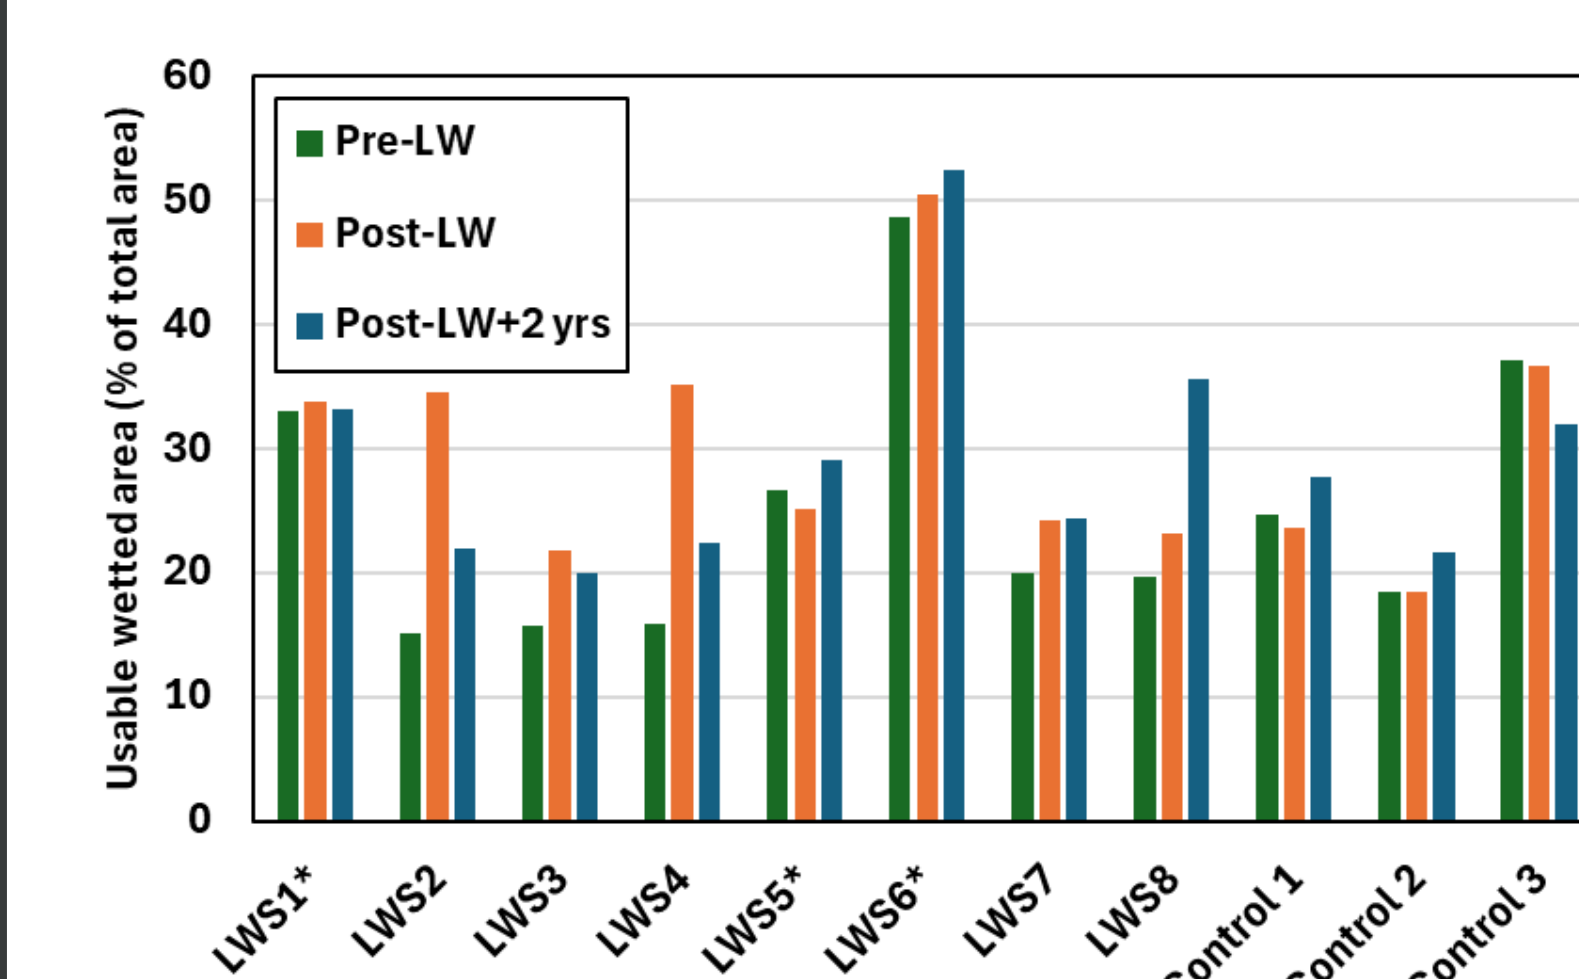
Figure 5 Modelled proportional areas of wetted channel with theoretical tolerable velocities for parr. * denotes medial structures.

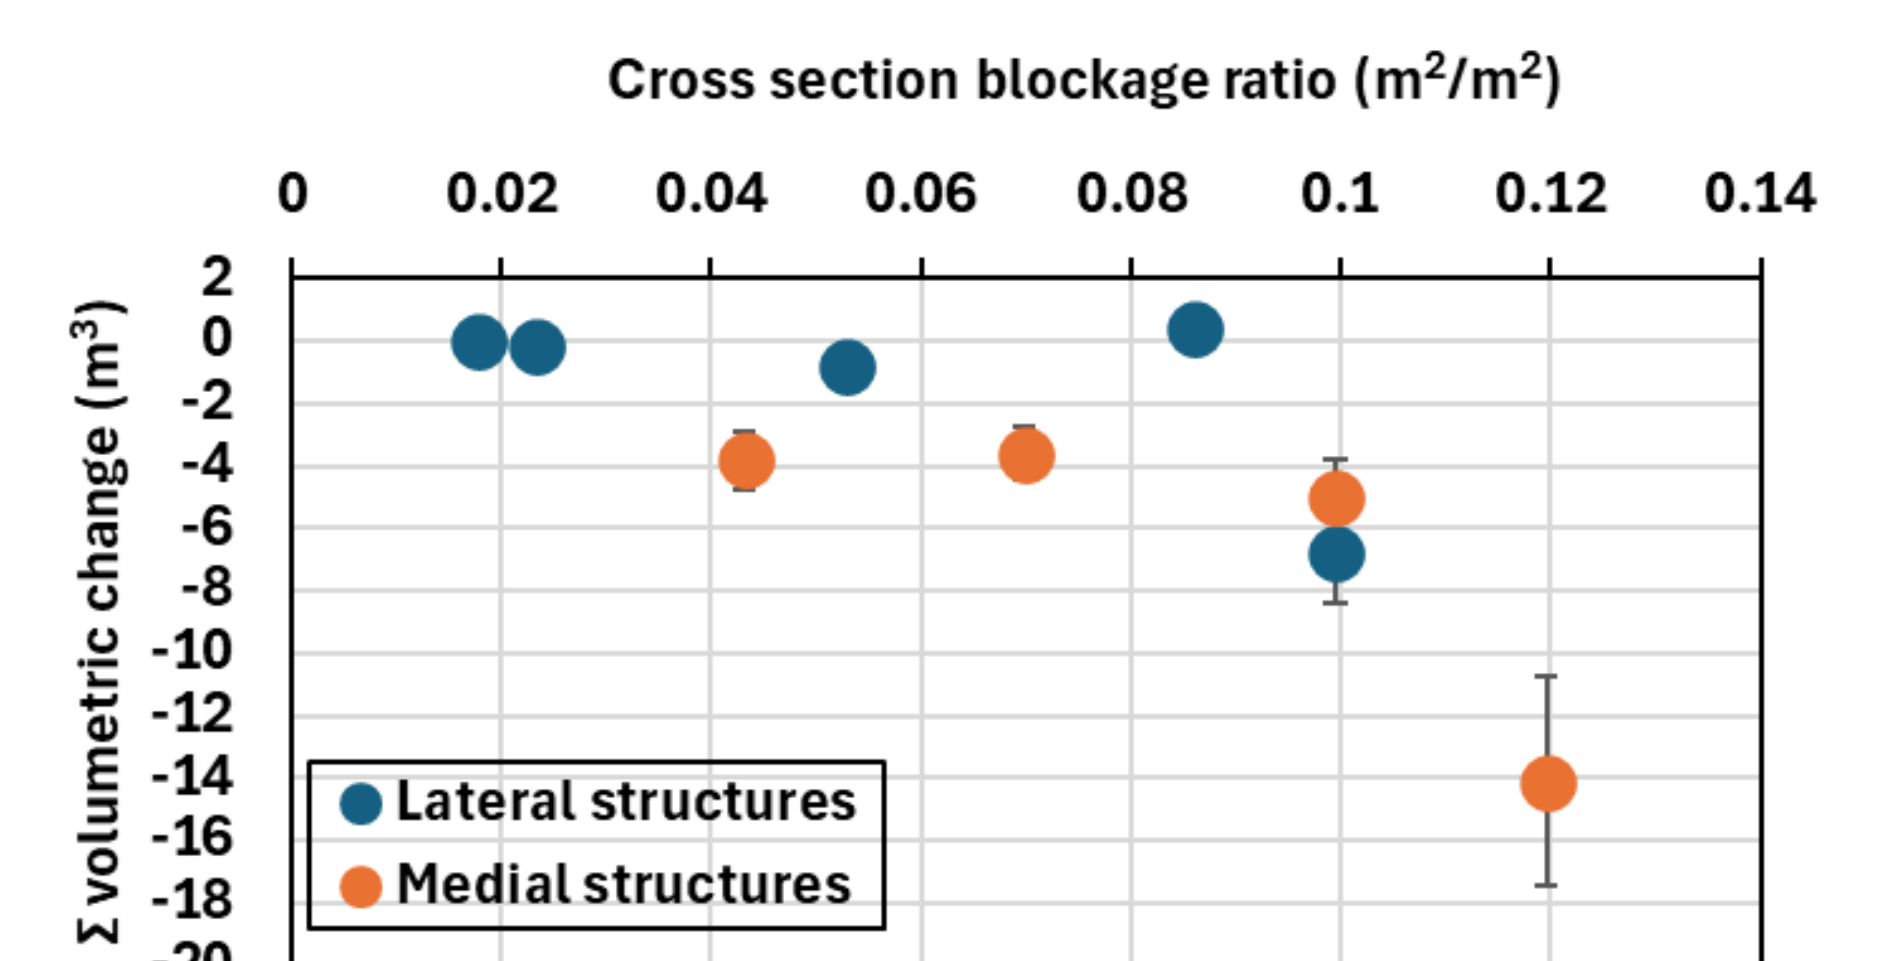
Figure 6 Relationship between frontal LWS cross section bankfull blockage ratio and net morphological change.

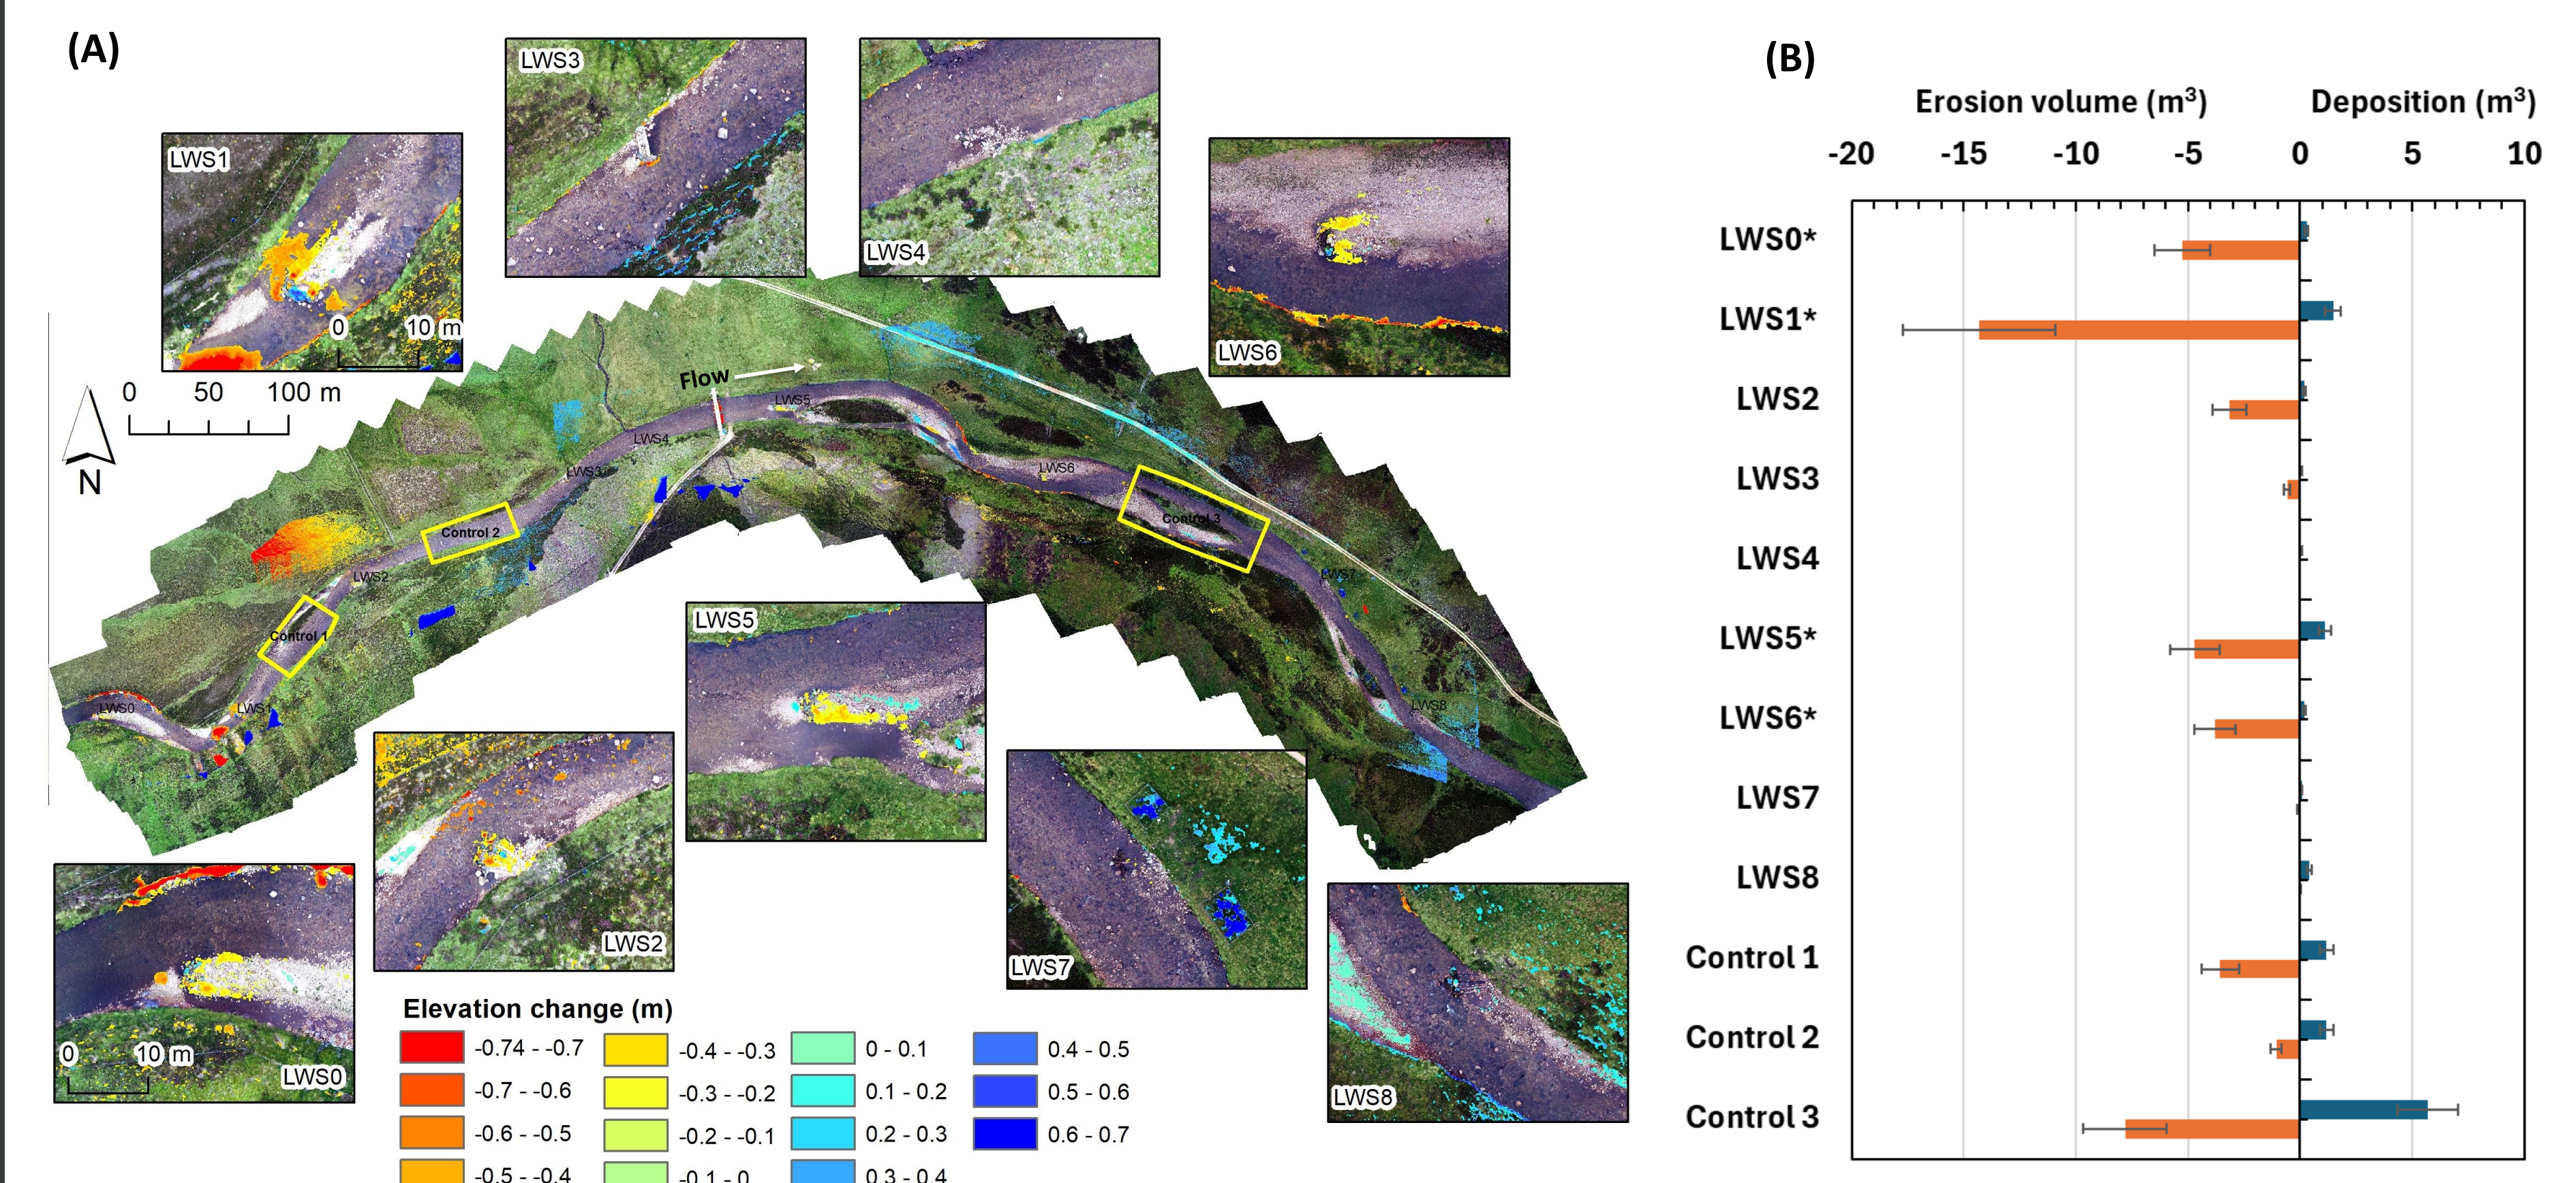
Figure 7(A) DEM of difference results for post-LW +2 years minus pre-LW installation. (B) Corresponding erosion and deposition volumes for each structure and control area. * denotes medial structures.
