Implementation and monitoring of natural flood management in Scottish upland catchments.

Steve Addy, Mark Wilkinson, Helen Watson and Marc Stutter

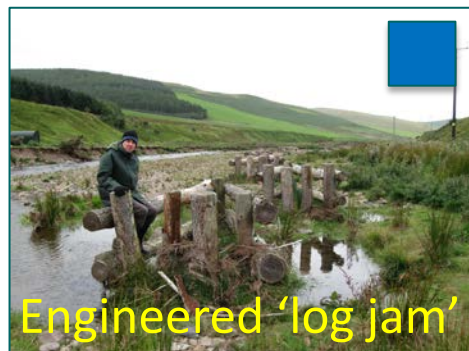
Engineered 'log jam'

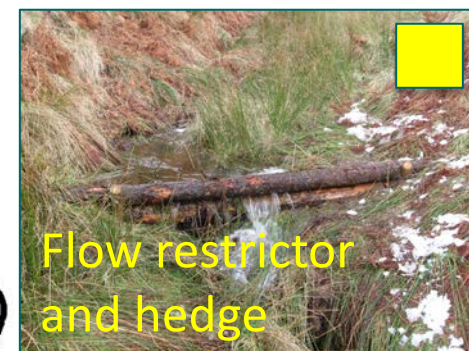
Flow restrictor and hedge

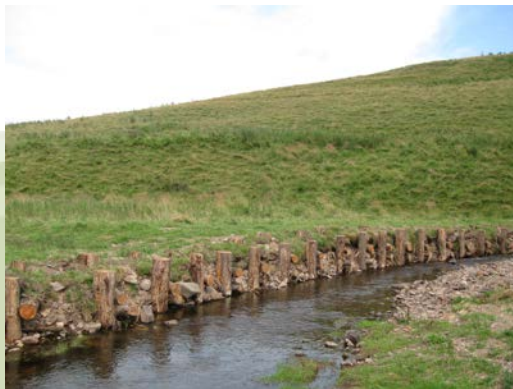
Bank protection

- Wood incorporation is potentially a way of reinstating natural geomorphic processes and delivering flood management benefit.
- A lack of evidence and guidance in a UK context.
- Six types of wooden structure trialled: three types to protect banks, one type to control channel grade, one type to trap sediment and one to restrict flows.

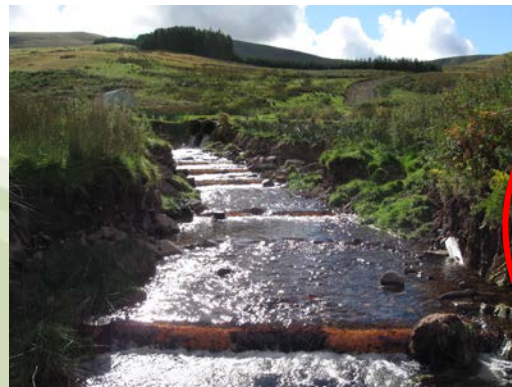
Grade control

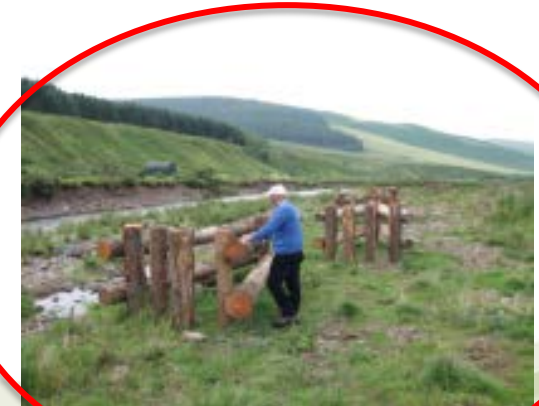
'Bar apex' sediment trap

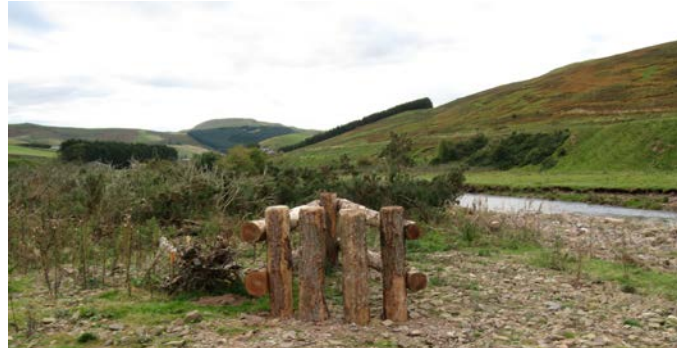
Total intact: 34

Structure survival (Aug 2012 – Jan 2014)

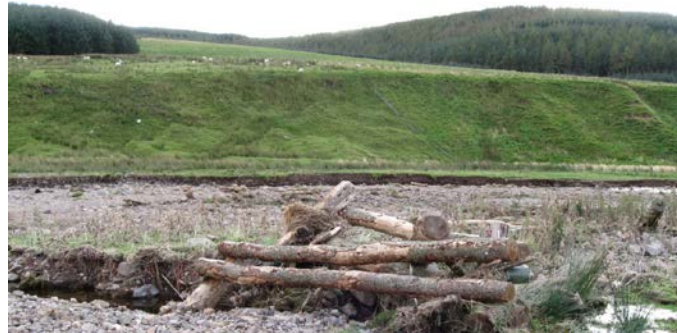
Total damaged: 6

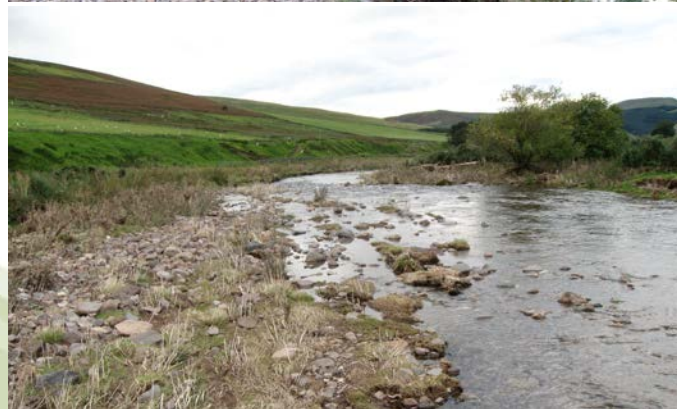
Total destroyed: 5

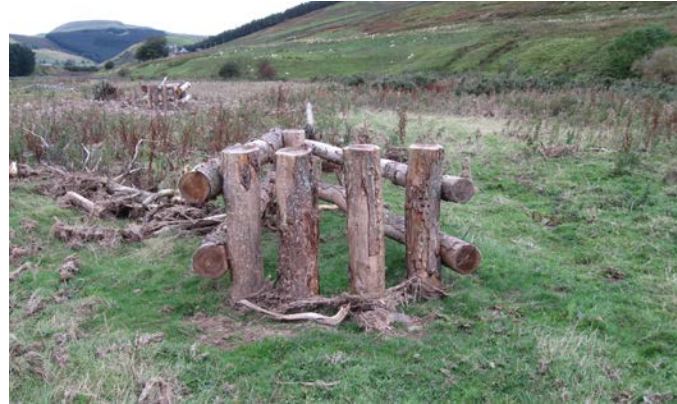
Total no deposition: 15

Bar apex deposition effects (Aug 2012 – Jan 2014)

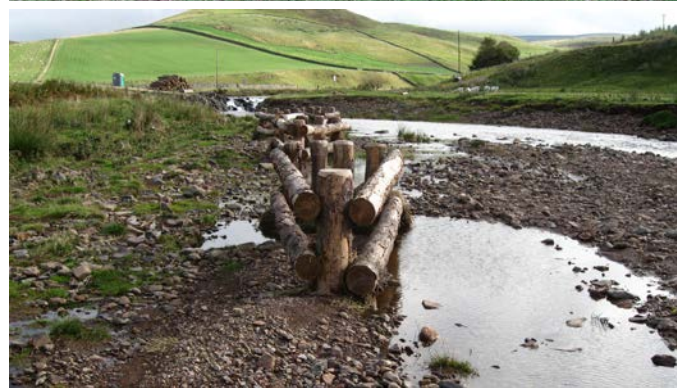
Total minor deposition: 25

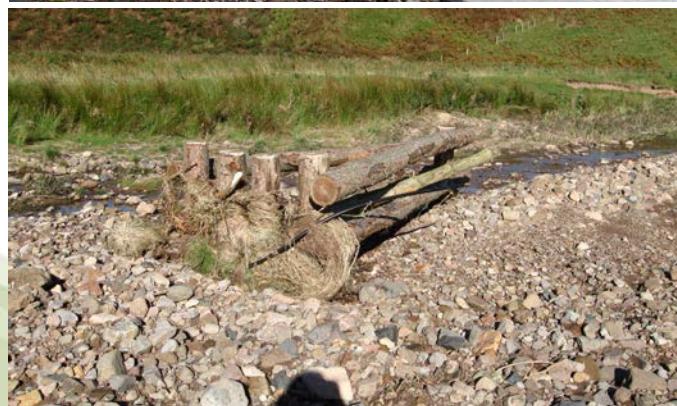
Total major deposition: 5

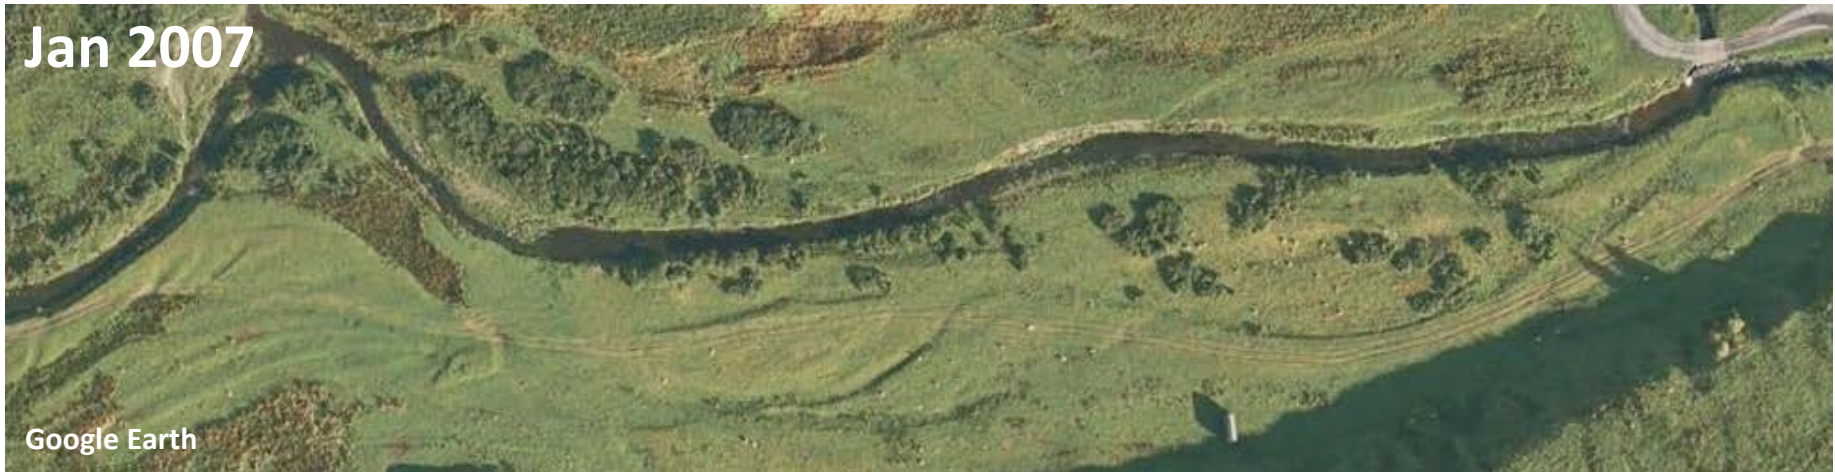
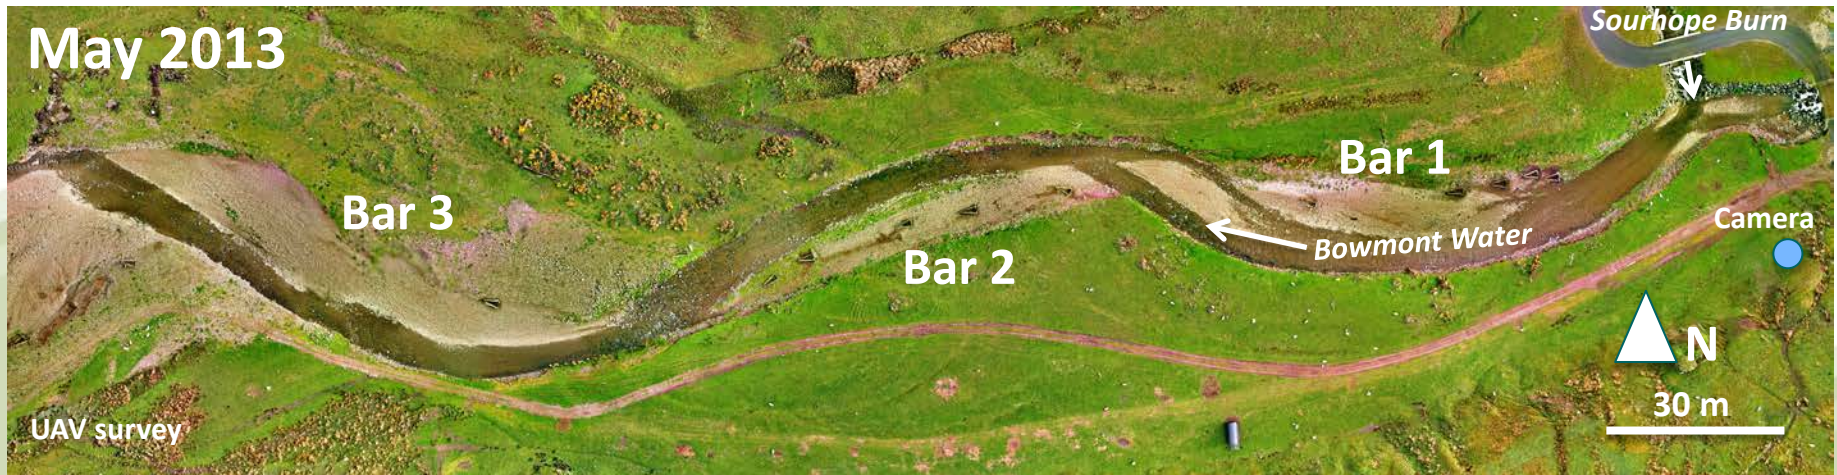
Swindon Haugh reach (28 km²)

- Jul 2009 - Oct 2012: mean 0.25 m of aggradation (max 0.56 m)
- 2007 – 2013: up to ~20 m of active channel widening

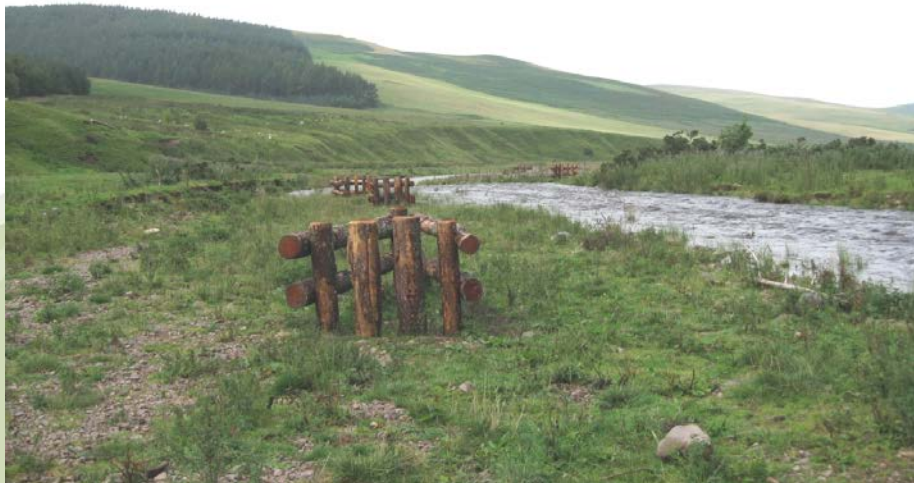
Effectiveness of ELJs – Bar 2

Bar mean elevation change: +0.13 m

Bar sediment volume change: +98.7 m³

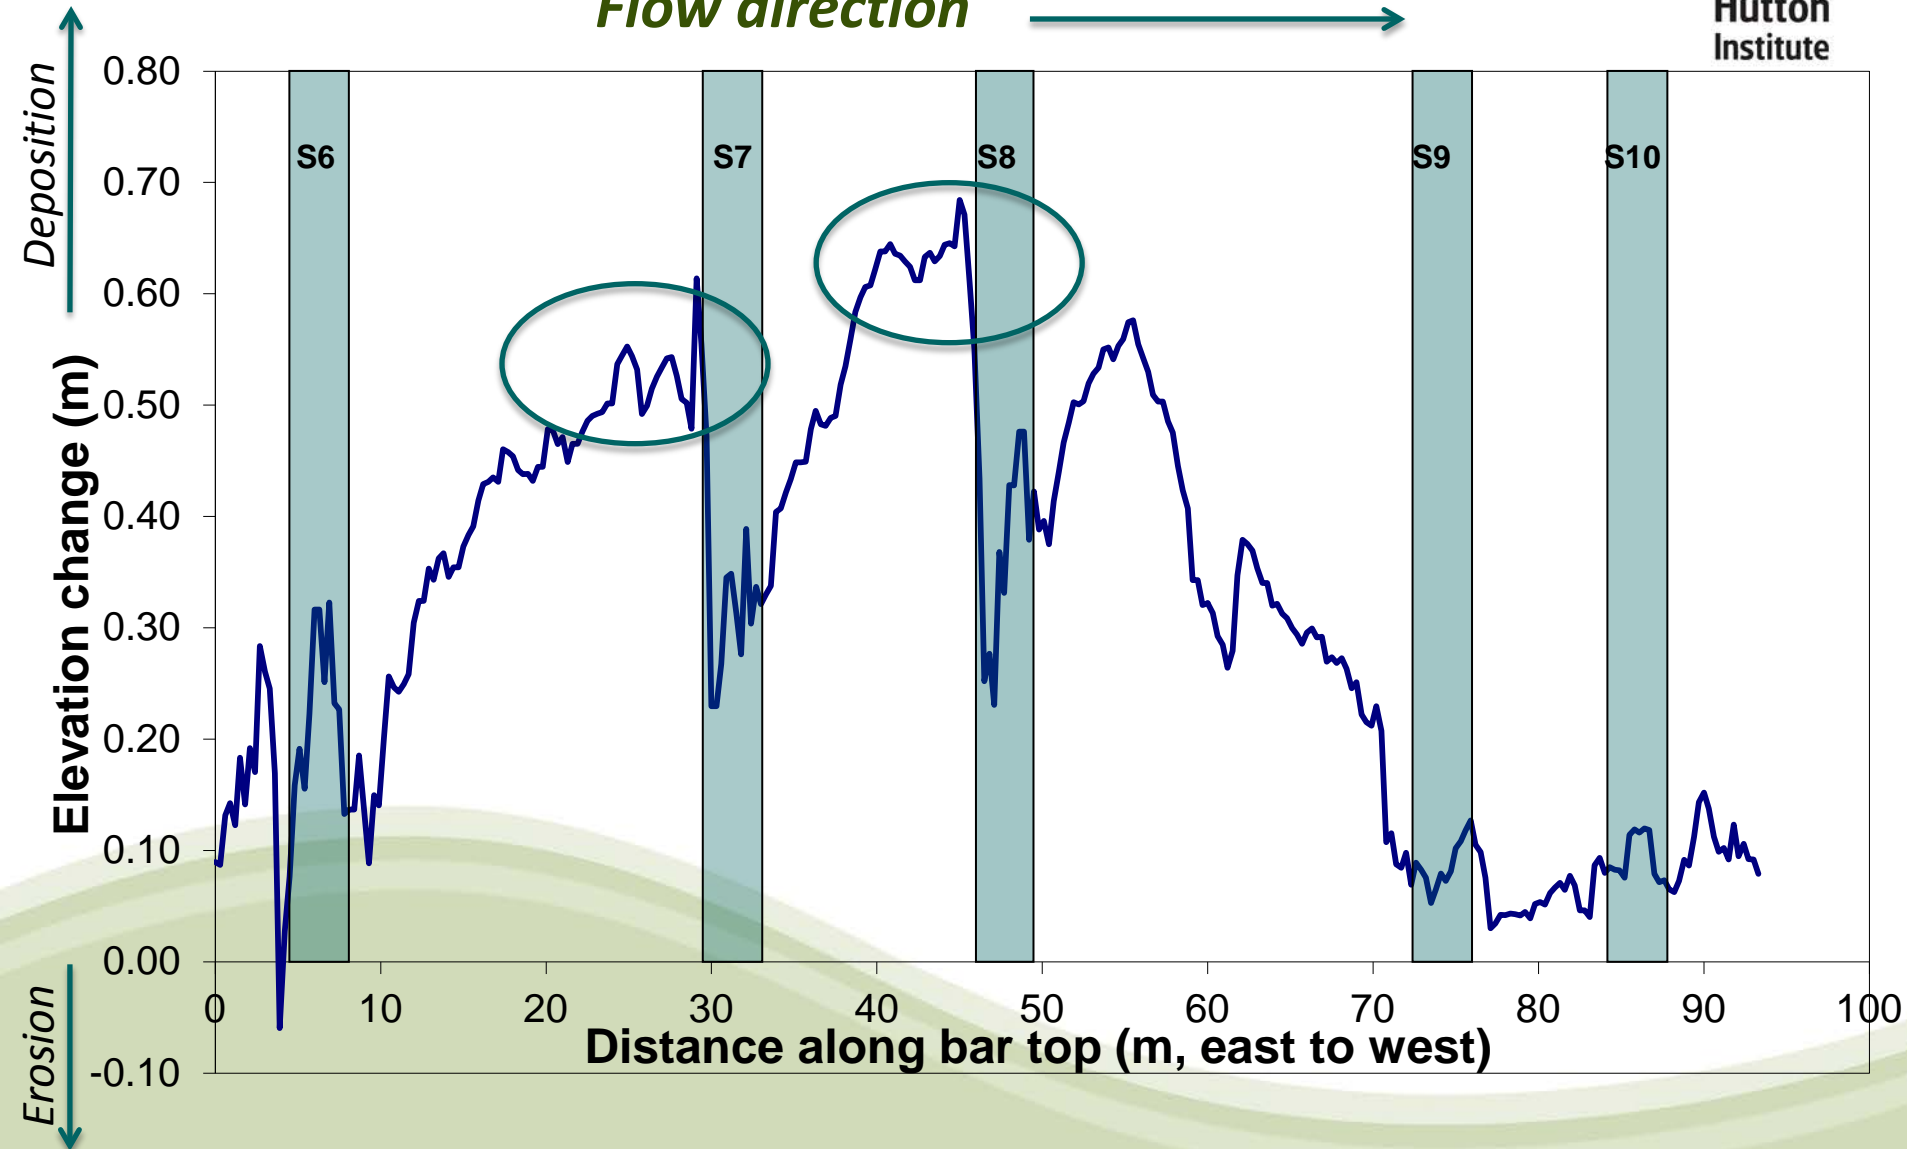
Bar 2 geomorphic responses

Flow direction →

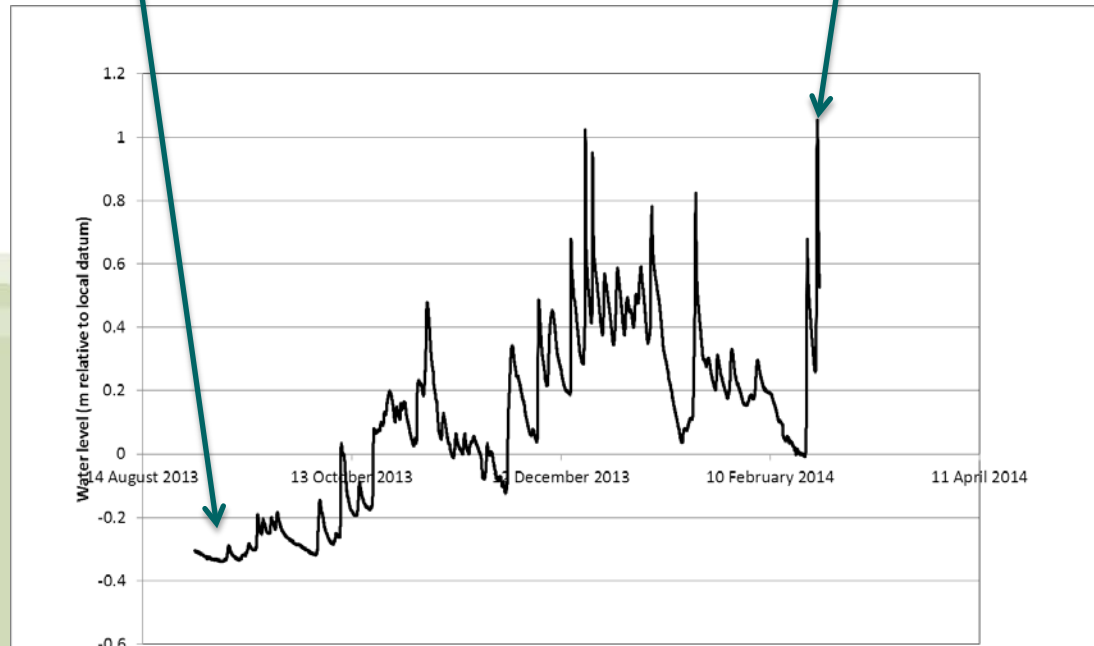
Winter snowmelt event
