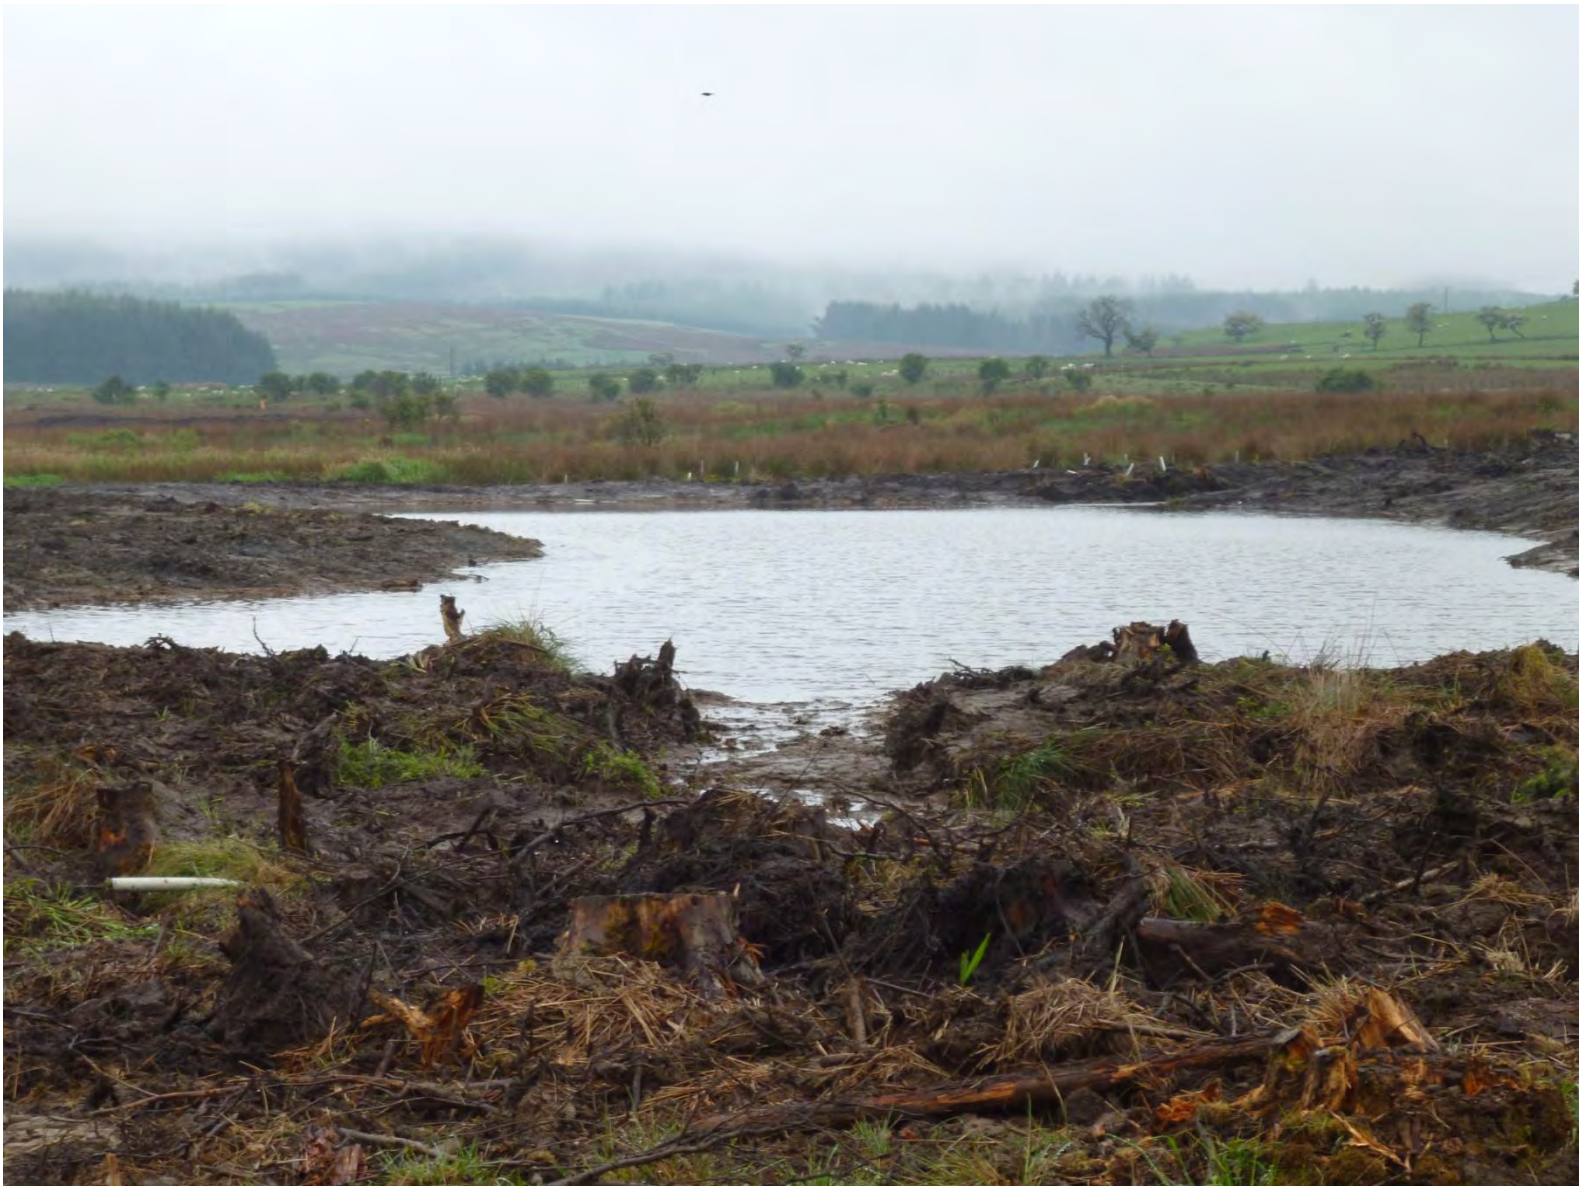
North Cloich - Flood storage pond in action— 5.6.2014

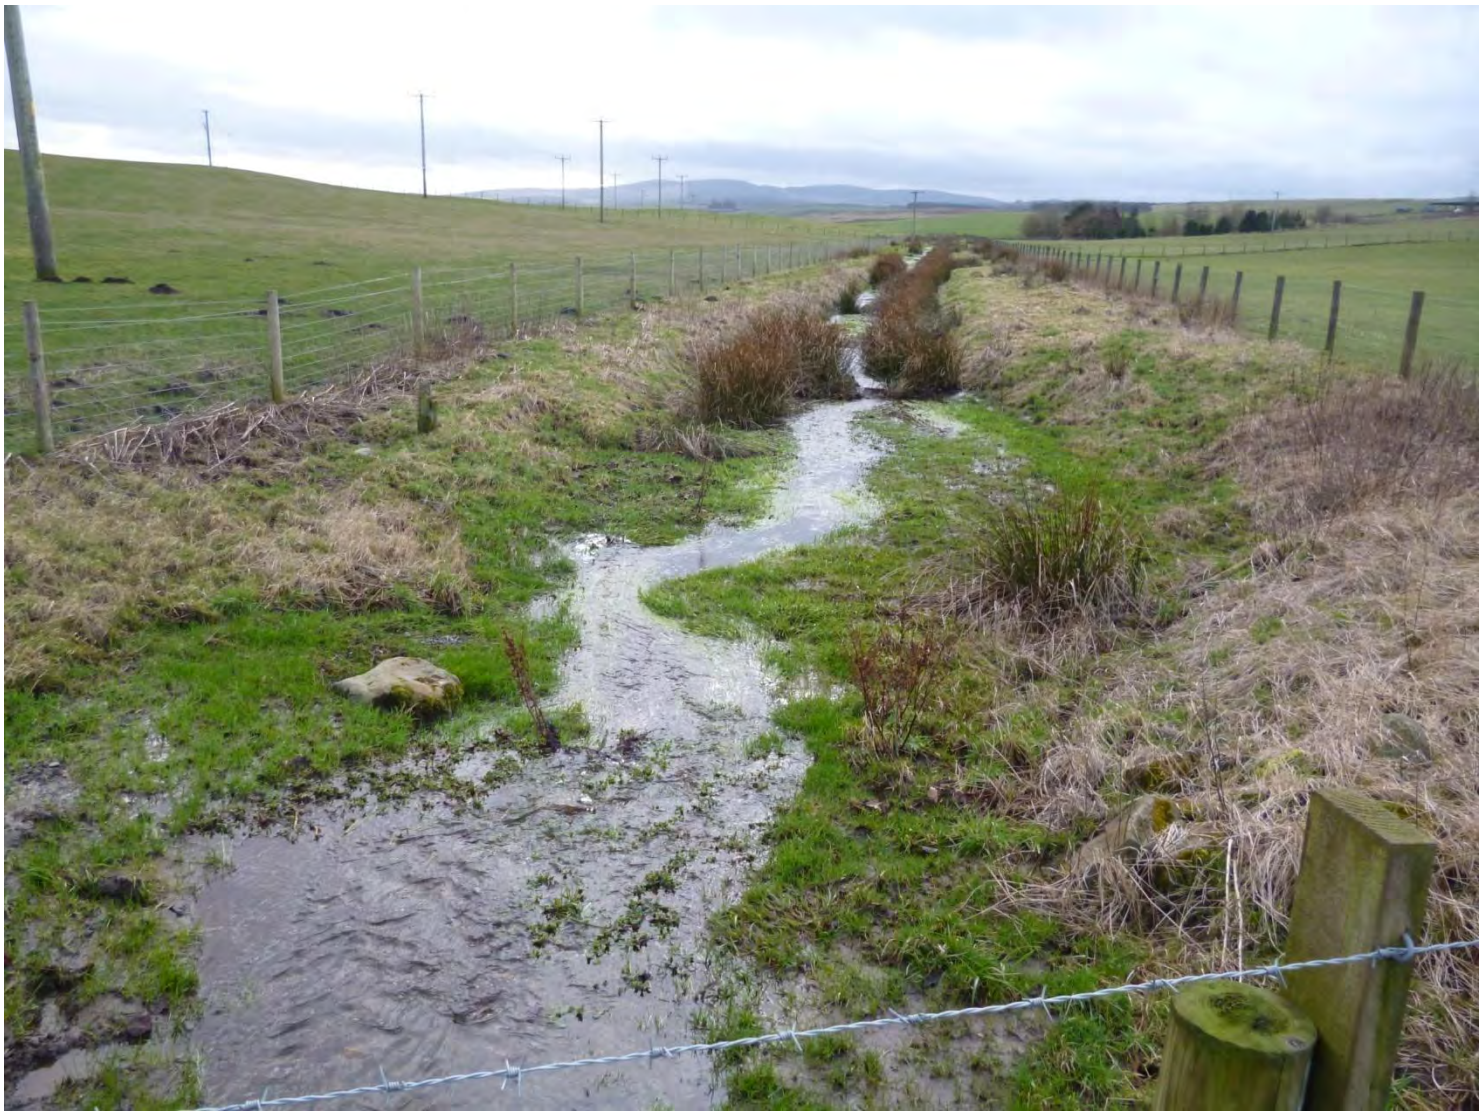
Craigburn re-profiling upstream reach. About to start

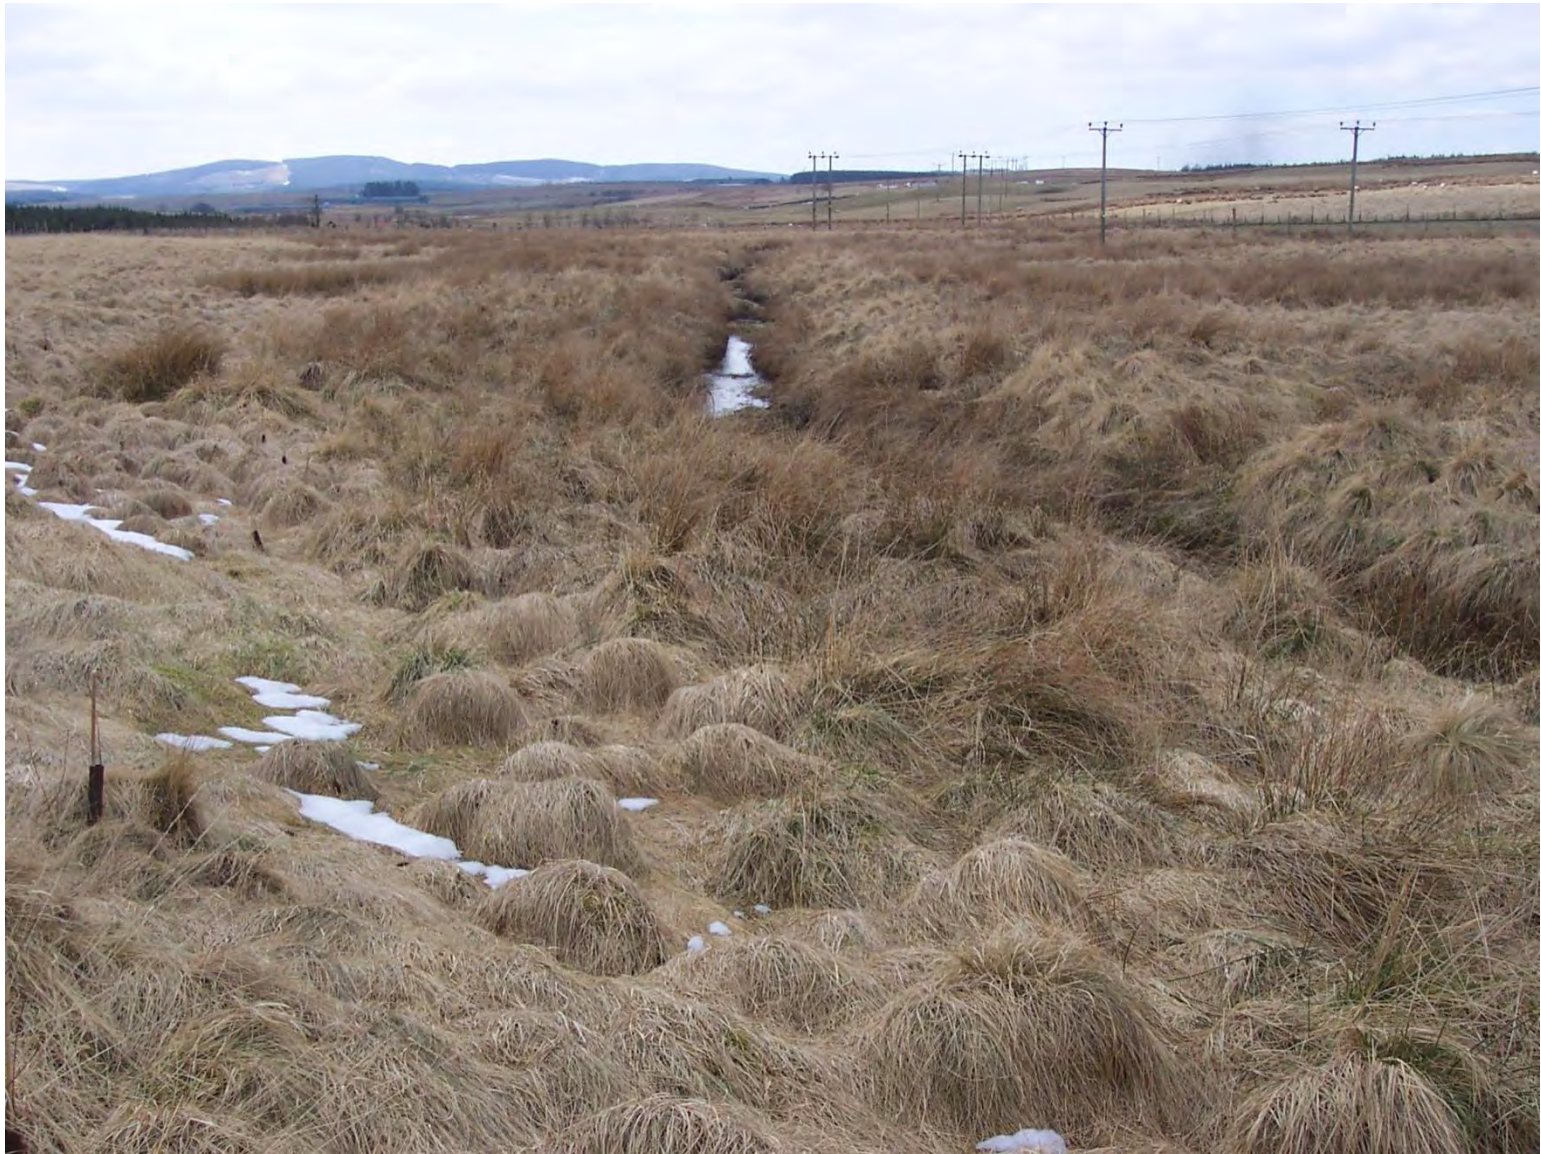
Craigburn 800m reach to be restored using 34 log jams. About to start

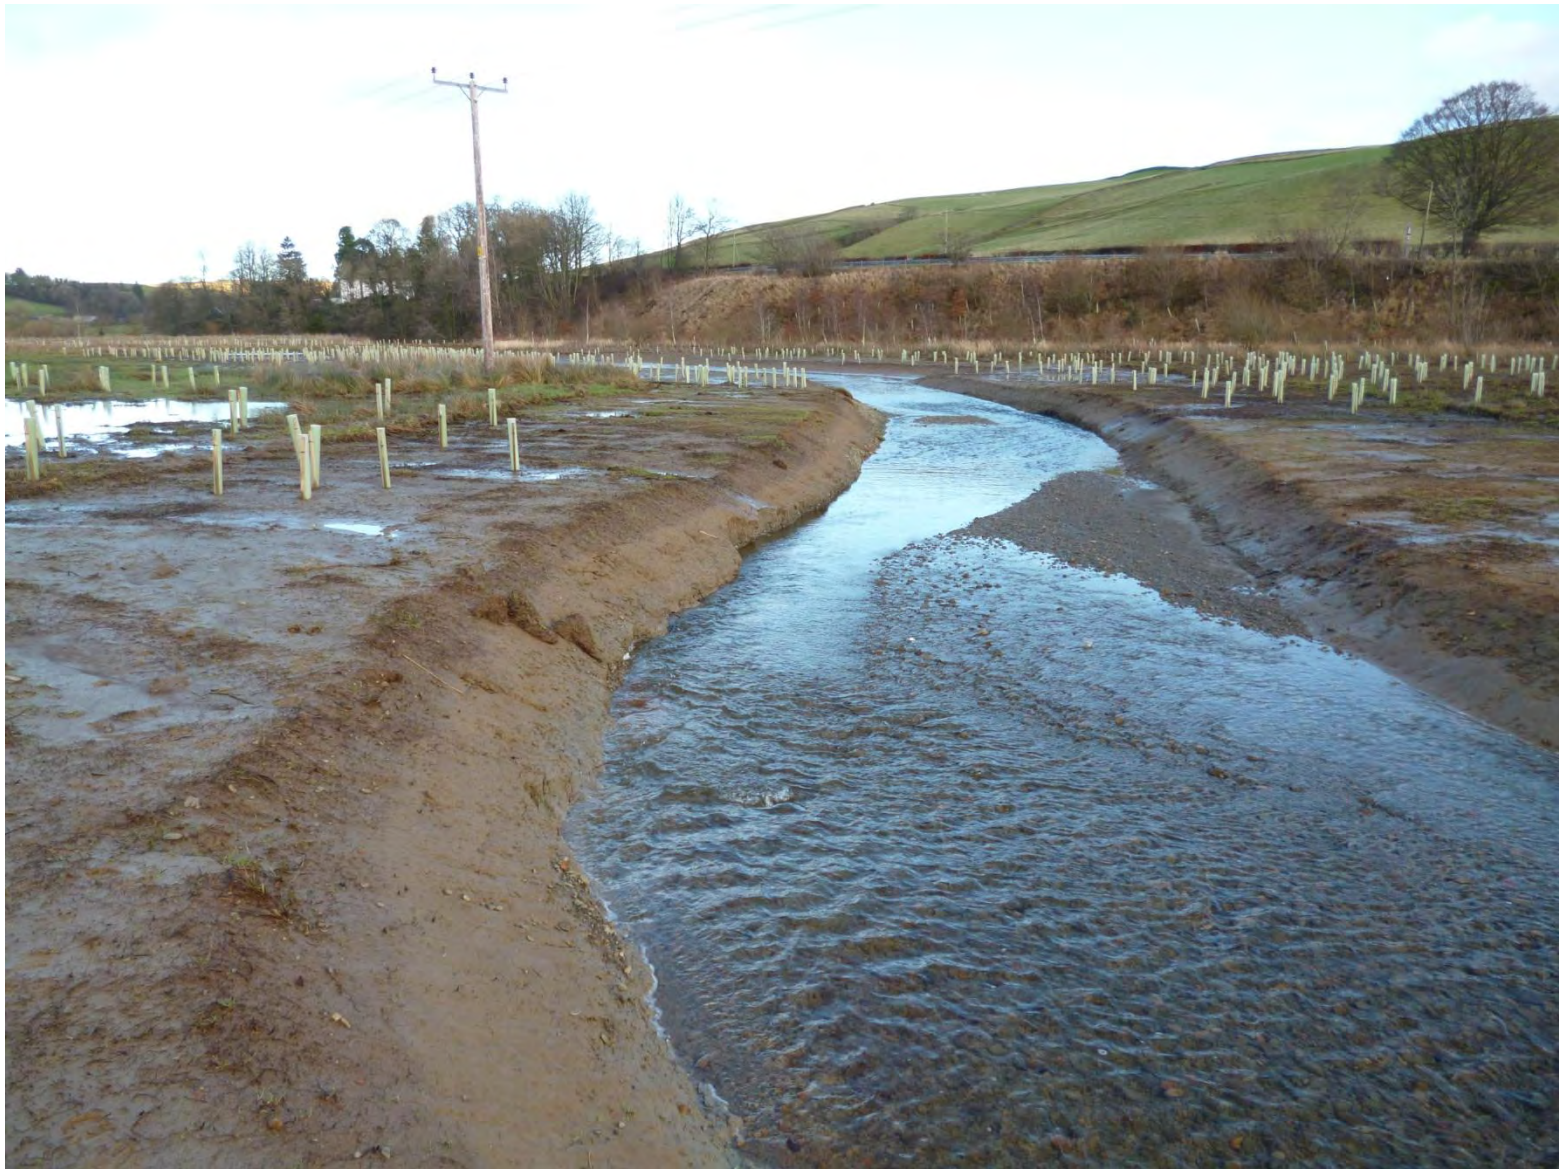
Bowanhill. Jan 2014. New channel developments

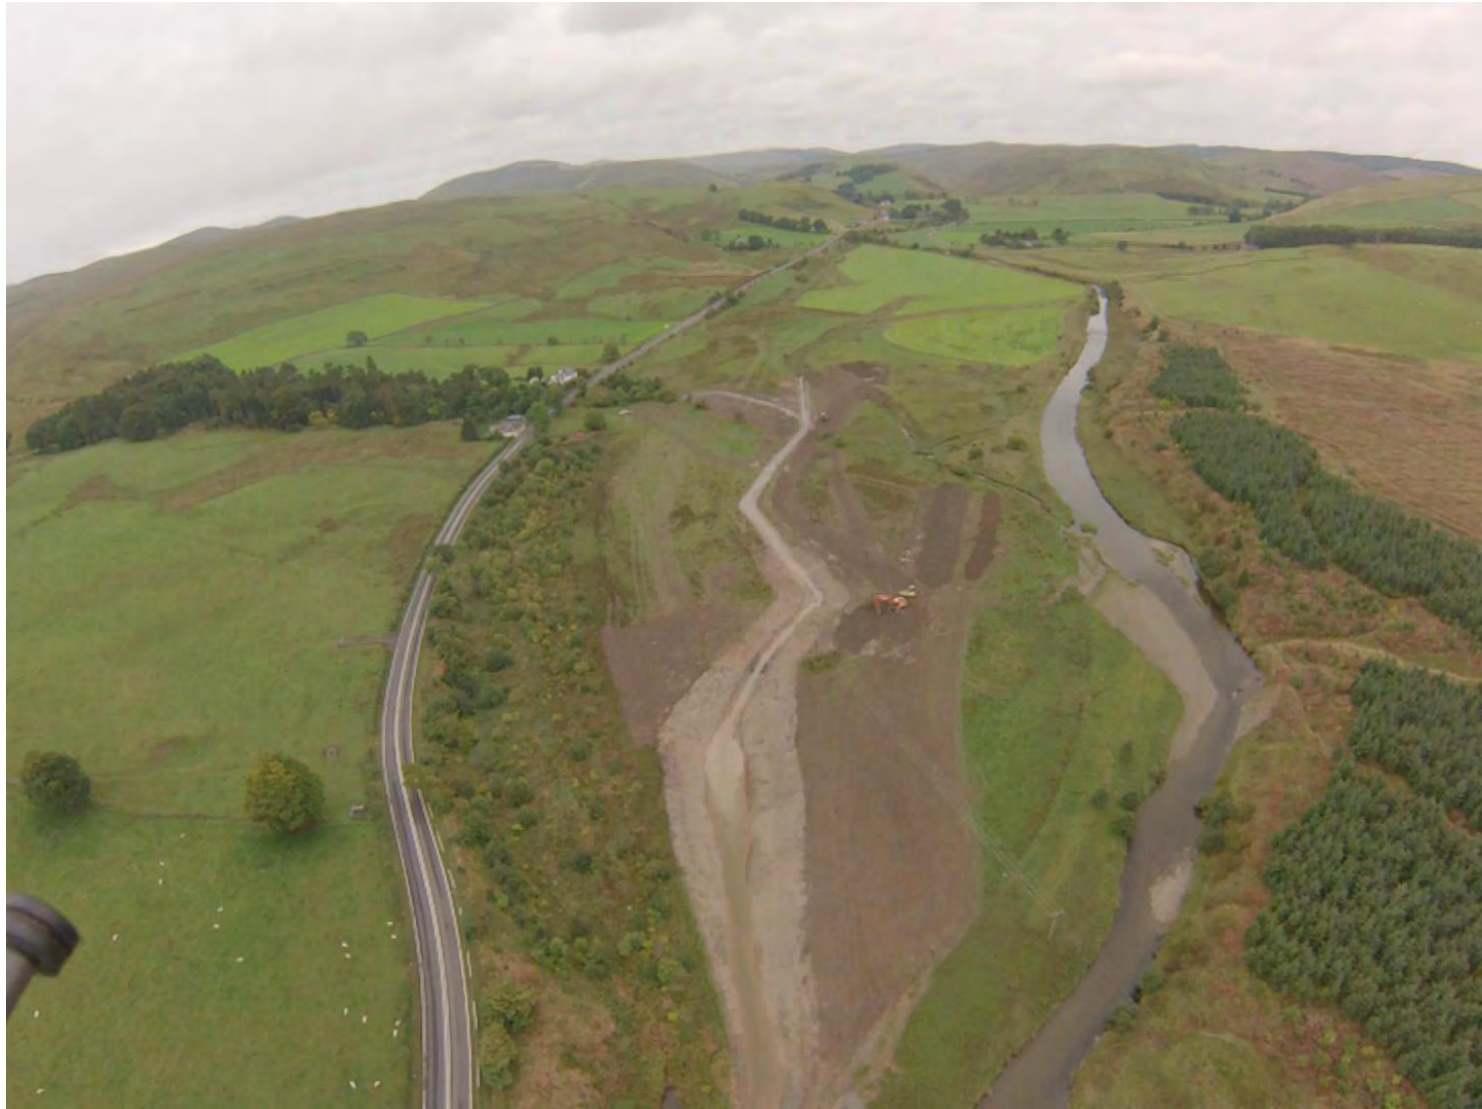
Bowanhill. August 2013. New channel route,

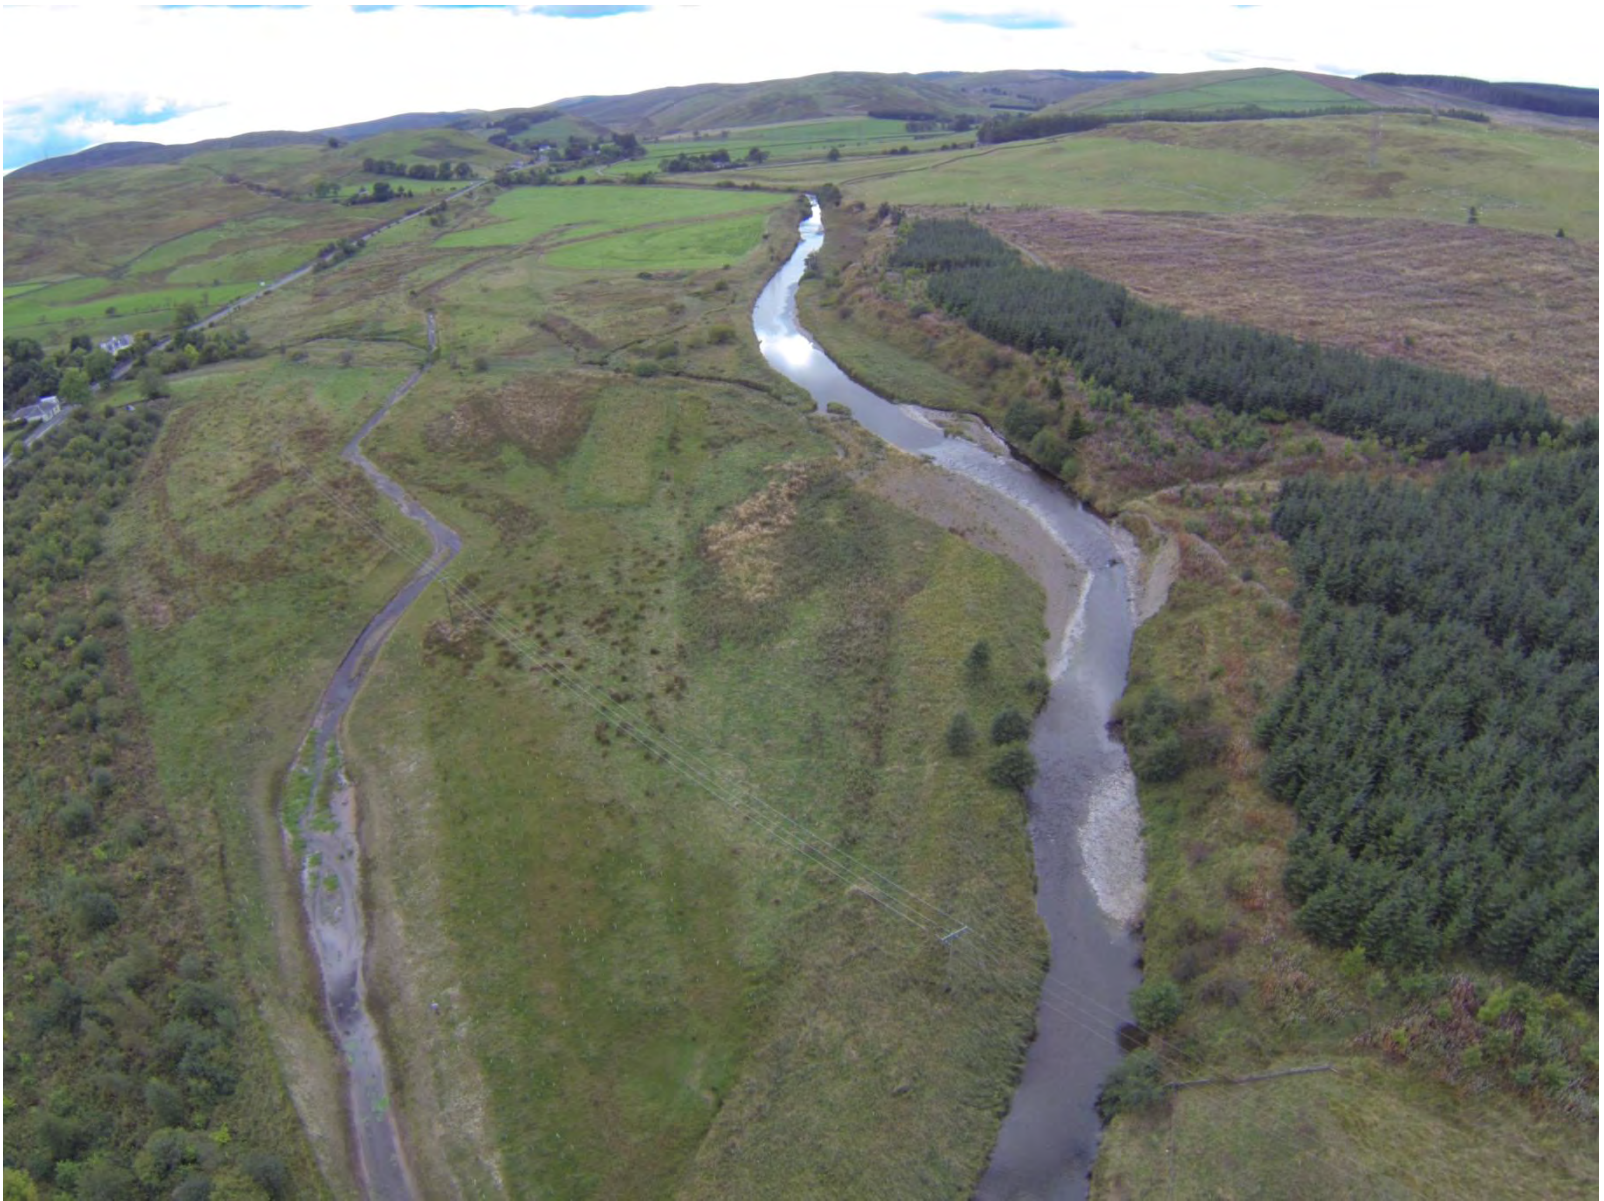
Bowanhill. Sept 2014. New channel route, vegetation regrowth

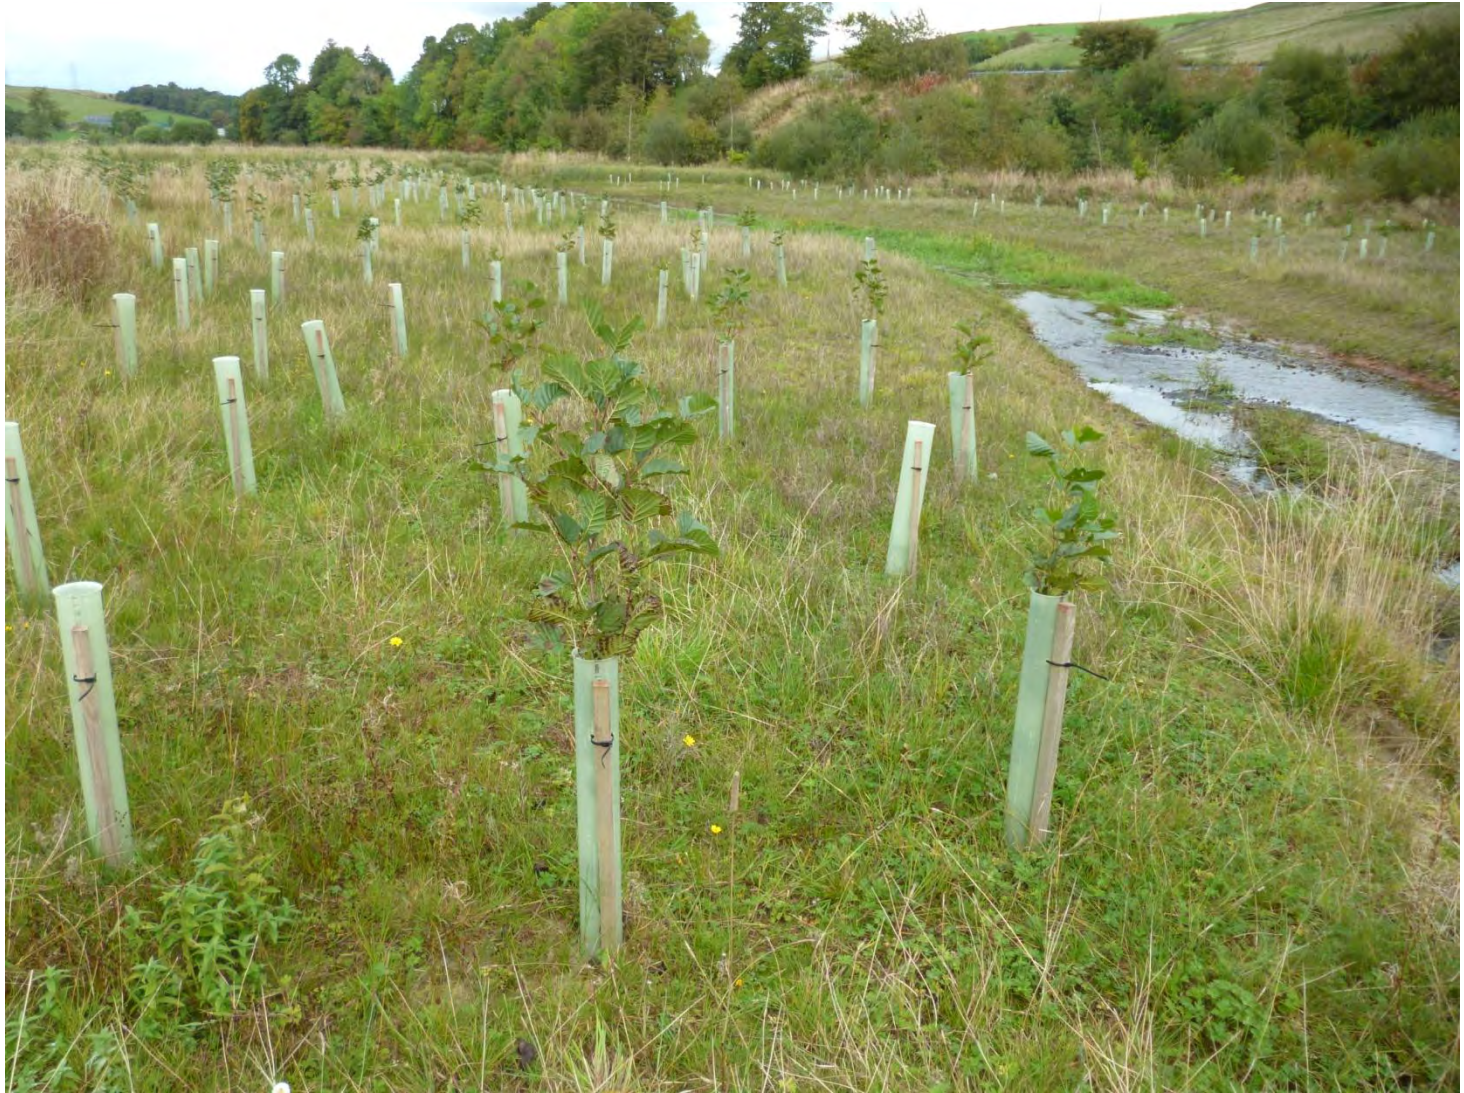
Bowanhill. Sept 2014. New channel , vegetation regrowth. SRDP wet woodland

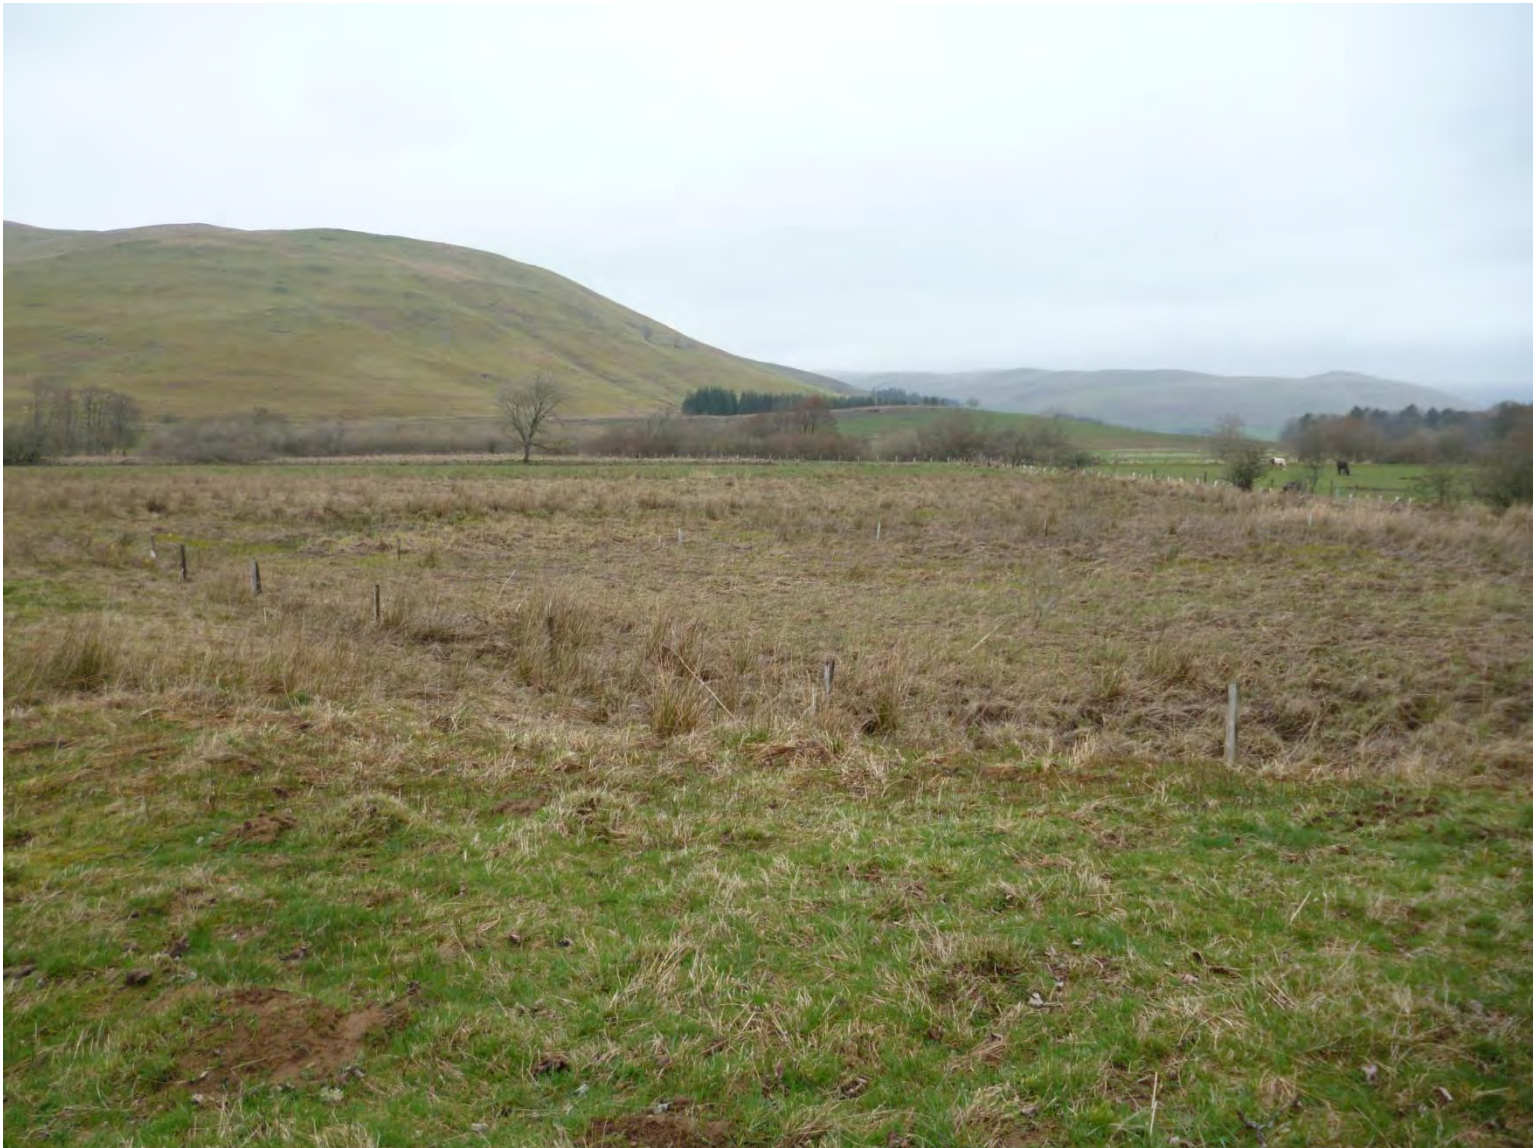
Annelshope, Ettrick, Flood plain flood water storage pond. 4.4.14

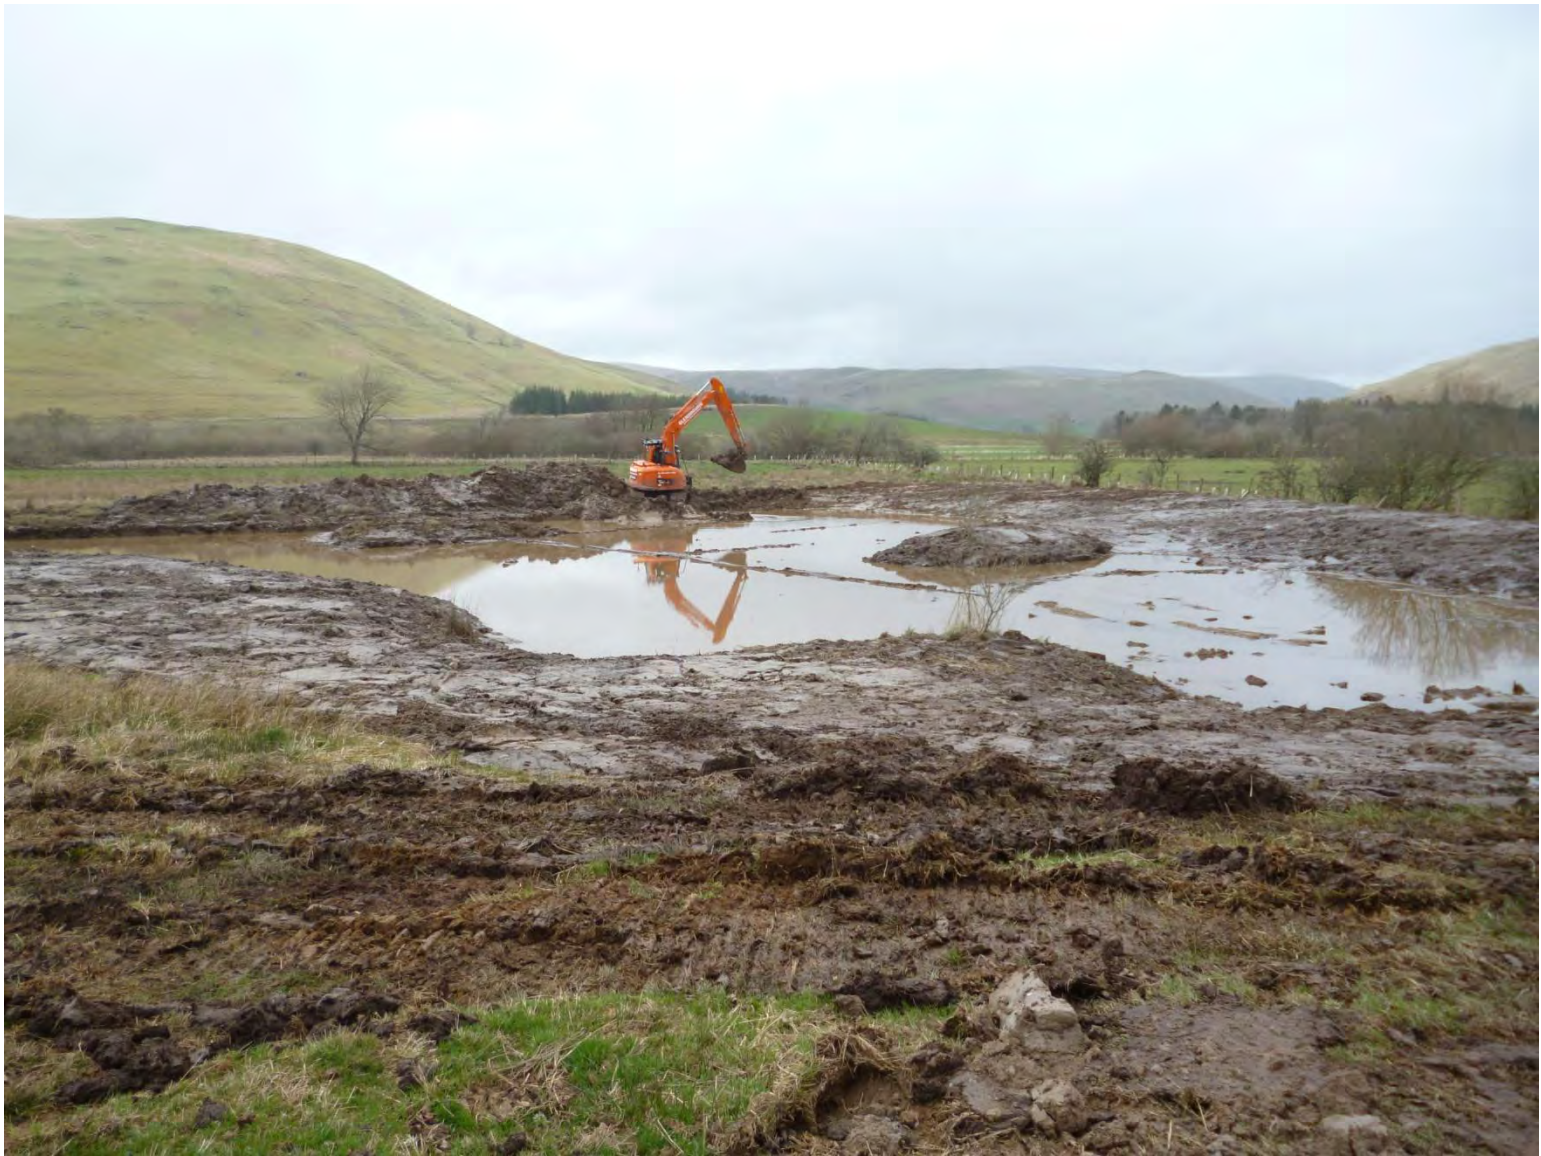
Annelshope, Ettrick, Flood plain flood water storage pond. 10.4.14

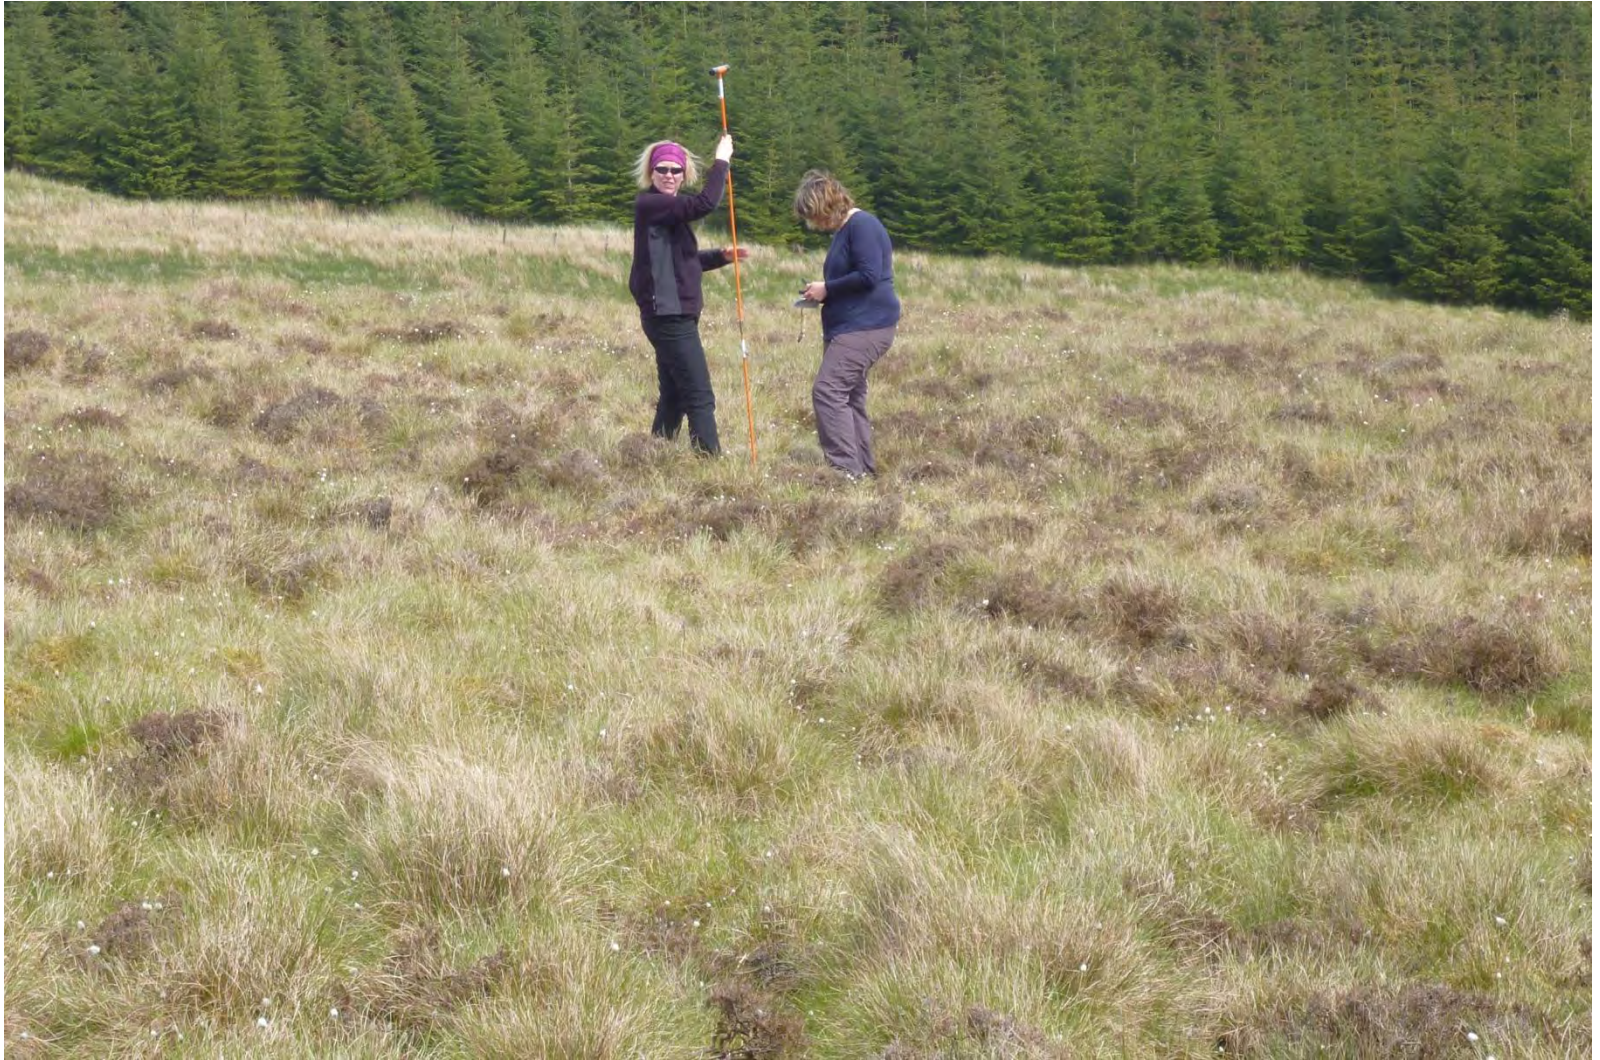
Mountbenger, Ettrick, Blocking eroding drains on deep peat. Measuring peat depth.

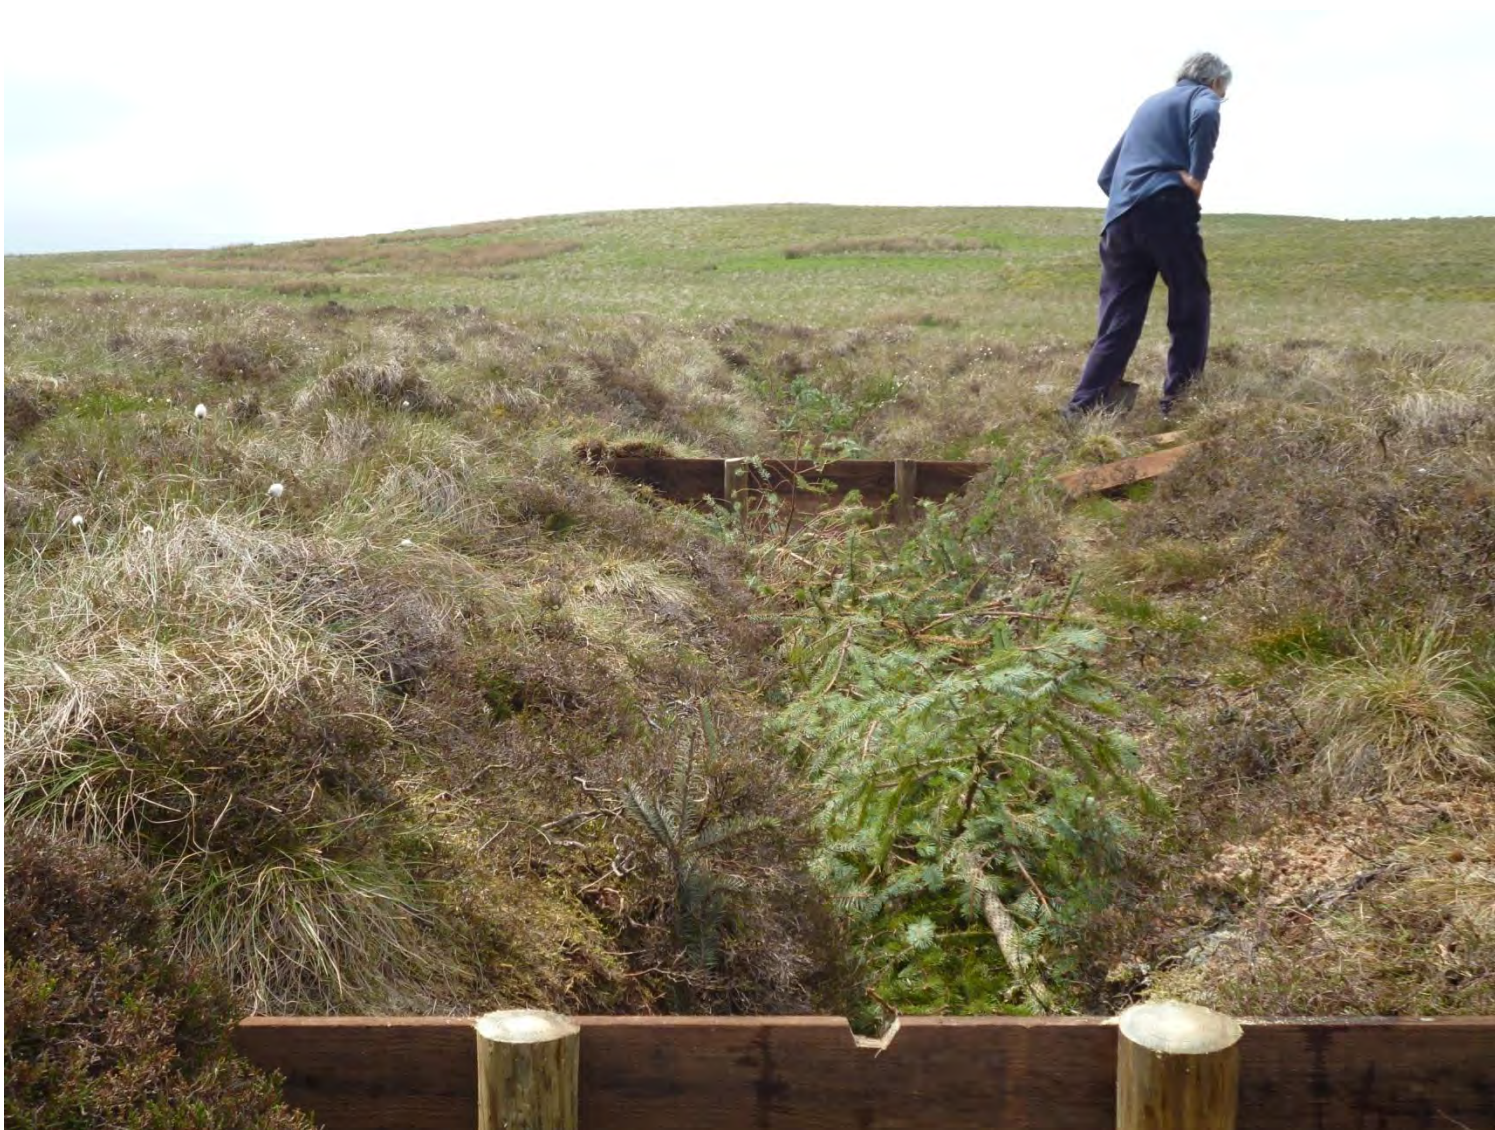
Mountbenger, Ettrick, Blocking eroding drains on deep peat. SBC Glenkerie funded activity.
